INVESTIGATION OF THE CAUSES OF THE CRIMINATION OF TURBINE CASTINGS AFTER OPERATION OF 100 THOUSANDS. HOURS²³

**Tkachenko D., master of group MC-55-23
Kharkiv National Automobile and Highway University**

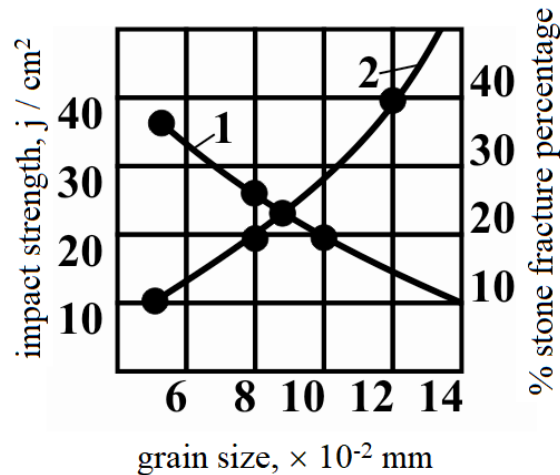
A comparison of the microstructure with the fractures indicates that one of the causes of the stone-like fracture is large grain.

Figure 1 - The relationship between toughness and fracture structure parameters: curve 1 - between toughness and grain size; curve 2 - between the percentage of stone-like fracture and grain size
