ENVIRONMENTALLY SAFE TECHNOLOGY FOR INCREASING THE DURABILITY OF HYDRAULIC HAMMER PARTS⁷

Tunyk V., student of group MC-51-21, KhNAHU

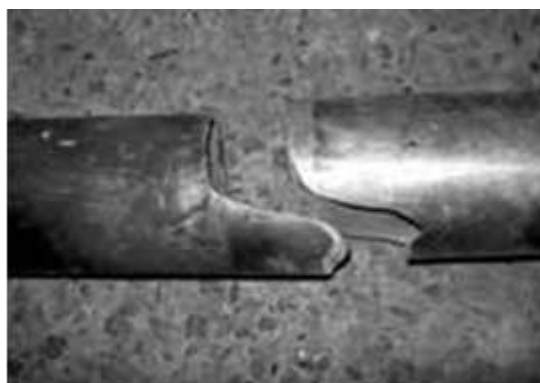
Fig. 2. Broken spade

The analysis of the work of the hydraulic hammer showed that the longevity of its operation depends on the main working tools: picks, hammer, bushings and the body of the hydraulic hammer (fig. 2).

The body of the hydraulic hammer - the pickaxe - is prone to wear. The tip of a hydraulic hammer can have different shapes: conical, pyramidal, shovel, chisel. The choice of the shape of the peak depends on the type of material to be destroyed.

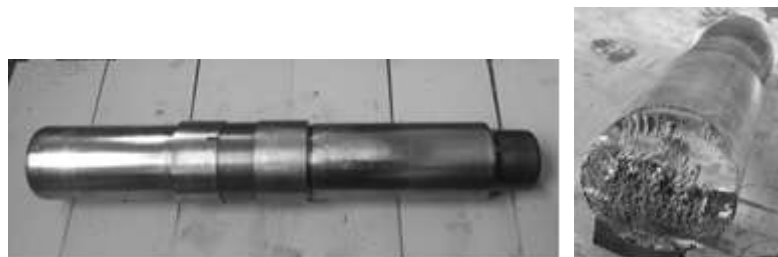
Fig. 3. Hammer striker (general view) and fatigue failure of the hammer striker in the process operation

Peen is the main element of the hammer. A fight is this certain mass m , which is required move to some distance from tool and to disperse to given speed V to the side tool [1]. In order to disperse fight to the right speed, to him necessary to attach the corresponding force, the magnitude of which is defined pressure working family and the area on which it acts this pressure as well gas pressure in the pneumatic chamber and appropriate area the end of the striker on which it acts gas pressure.

One with the main causes of destruction fights is fatigue metal, specialists allocate sufficient attention study and determining the reasons for leaving failure of the relevant parts of the hydraulic hammer, as well as on the increase their reliability and durability (fig. 3). On these properties hydraulic hammer has a great impact are doing applied materials, technology production and constructive features [2-5].

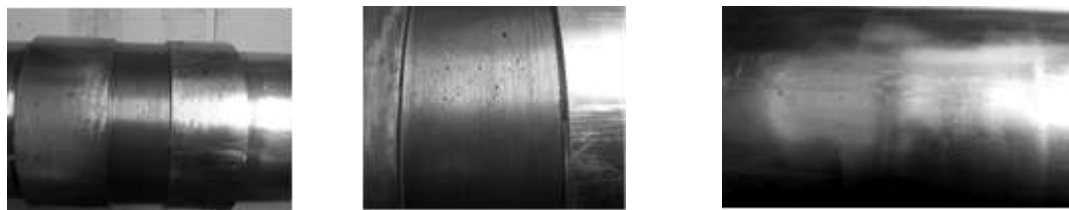
Fig. 7. Striker after operation: wear of the surface

On the surface of the hull channel, there are soot and colors variability (fig. 7).
