KHARKIV NATIONAL AUTOMOBILE AND ROAD
UNIVERSITY

**TECHNOLOGICAL APPROACHES
TO INCREASE PARAMETERS QUALITIES OF A
HYDRAULIC HAMMER**

Monograph

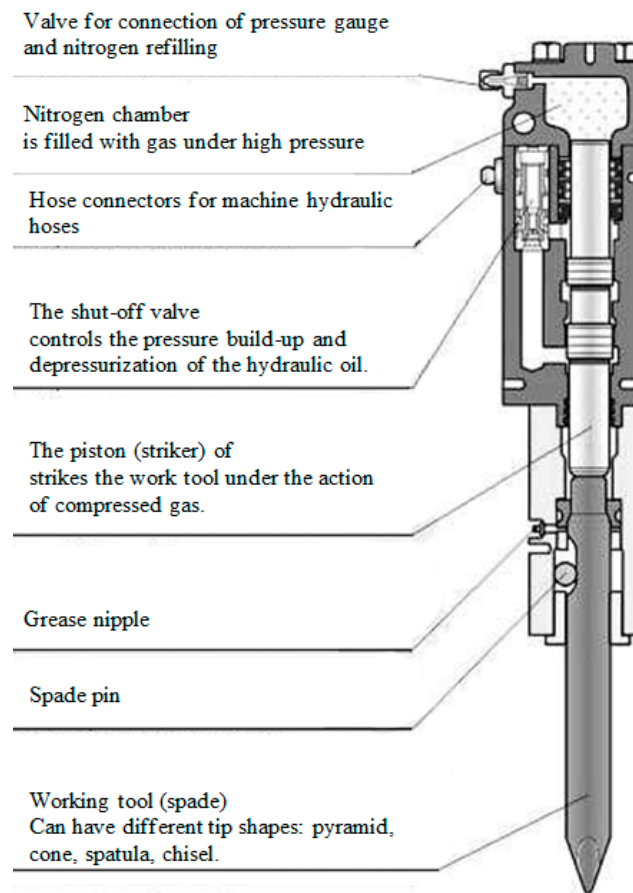
Figure 1.4. Scheme hydraulic hammers easy series DSM [13]

A distinctive feature of the DSM light series hydraulic hammers (Fig. 1.4) is the internal structure, which is a monolithic steel block without a tie bolt, which eliminated one of the main causes of hydraulic hammer failure and facilitated their maintenance.

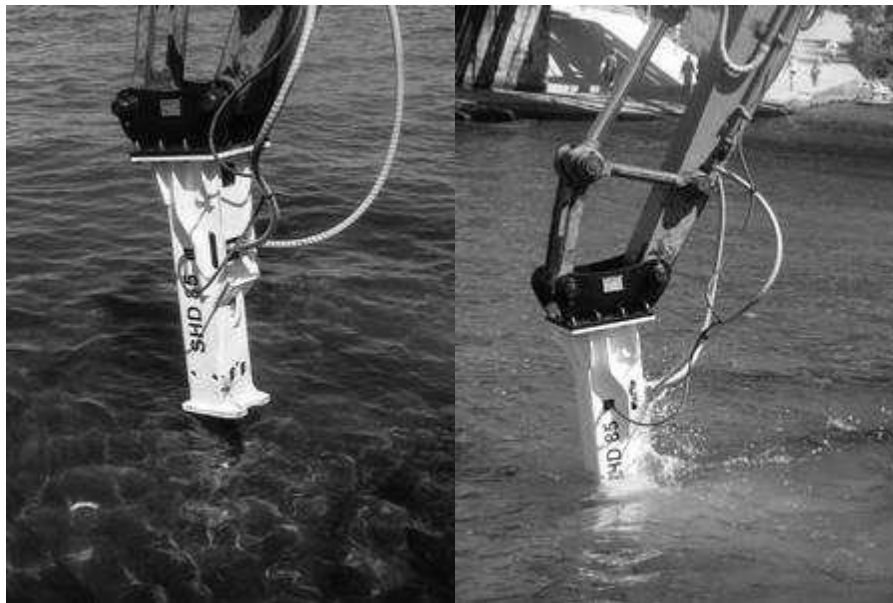
Figure 1.5. Usage hydraulic hammers under water [12]

If you use a hydraulic hammer underwater (Fig. 1.5), you will need to protect it from corrosion, water hammer and other damage. Given the specifics of performing work in such conditions, hydraulic hammers (for example, Steel Hand) are equipped with a ventilation system for underwater work. It allows air to be supplied to the chamber of the hydraulic hammer and prevents water from entering the strike zone of the striker on the peak. For example, at a gas pipe laying site in Sochi, the productivity of the Steel Hand SHD 85i hydraulic hammer, installed on a JCB JS290LC excavator, was 60–80 m³ developed soil in 8 hours of work.

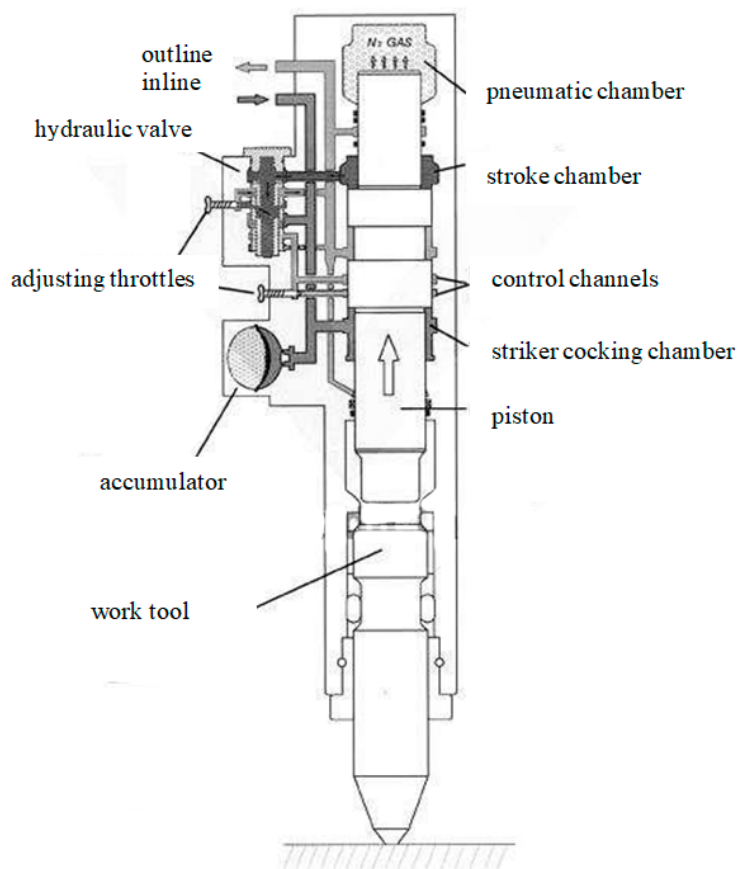
Figure 1.17. Hydraulic hammers Delta second groups: hydraulic line diagram [20]

- the cover of the working cylinder, which contains a piston accumulator-pneumatic chamber and a valve for charging the pneumatic chamber with compressed nitrogen.

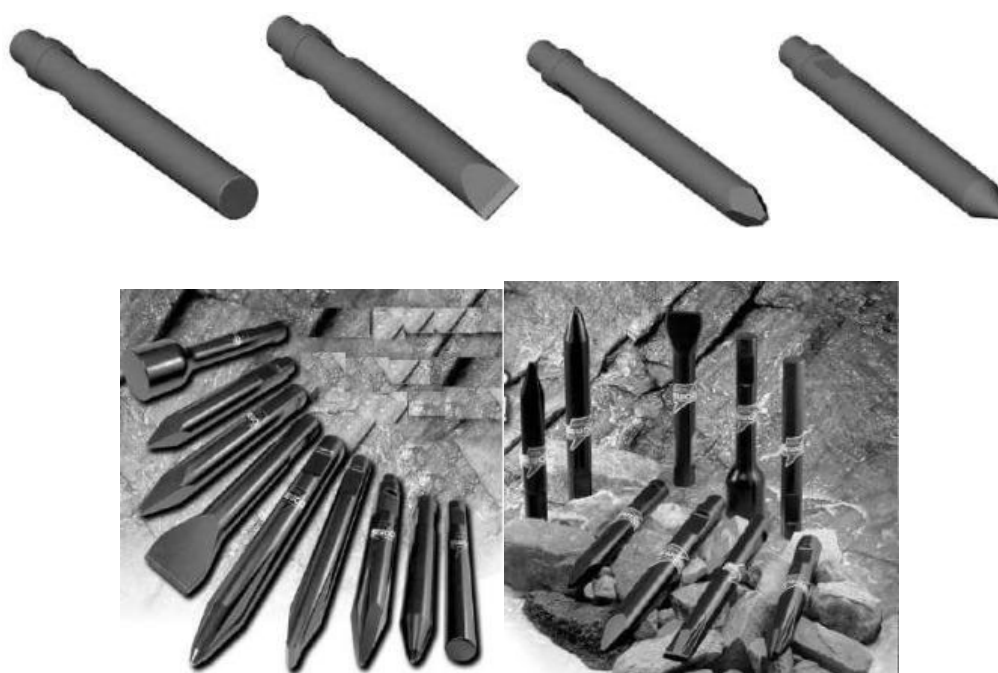
Figure 1.23. Configurations peak hydraulic hammer [17]

The forces acting on the hydraulic hammer pick are really very high. Therefore, the material from which it is made has high requirements. Firstly, it should be well-hardened steel containing a high percentage of manganese, chromium, vanadium, and nickel. Secondly, the workpiece for the future pick should not have internal defects - hidden cracks and cavities. Ultrasonic or magnetic diagnostics are used to test them. The pick can only be made of the best, almost ideal metal, then it will be sufficiently reliable and will not break at the first blow [11, 17].

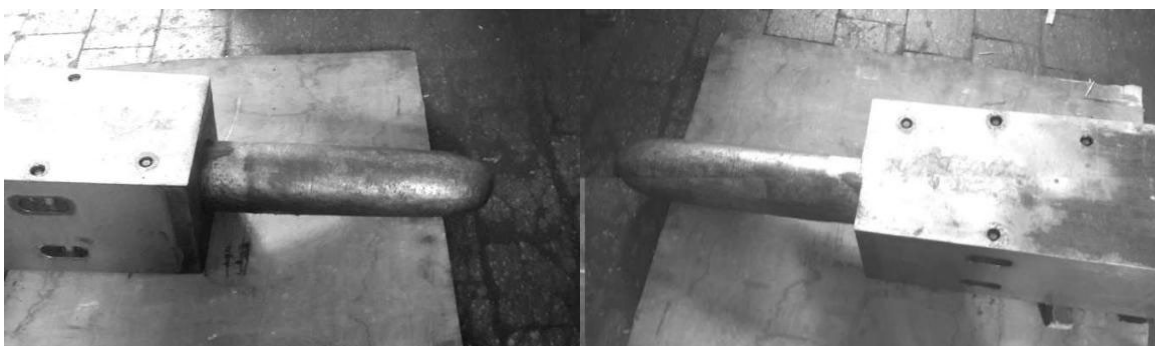
Figure 1.25. Pika hydraulic hammer (V collection)

No matter how well the hydraulic hammer pick is made, the service life her services in in many ways depends from correct operation (Fig. 1.25). During operation, the hydraulic hammer tool experiences intense impact loads, which create compressive stresses in it, and as a result of the reflection of shock waves from the tool tip and wave interference, tensile stresses. To these stresses are added stresses from the radial components of support reactions, from bending moments, which can arise for various reasons. Factories - manufacturers of hydraulic hammers prohibit work by them How with a crowbar, turning inside out pieces of material, but in practice such working methods are often used. In these cases, the tool is subject to a bending moment, and if the forces of the excavator's hydraulic cylinders are large and the cross-section of the tool is insufficient to withstand the bending stresses, the tool may burst in the area where it exits the axle box [17, 18].

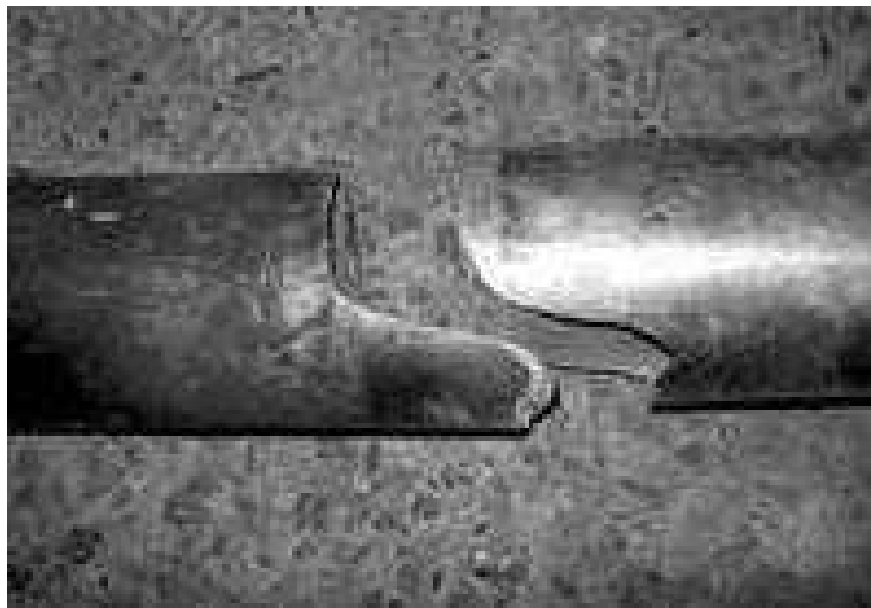
Figure 1.26. Broken peak [18]

Usually the tool is used even after its tip will accept rounded form. For example, on At the Zaporizhia Ferroalloy Plant, the destruction of oversized casting slag was carried out using a hydraulic hammer model D600. The length of the working part of its new tool, protruding from the axle box, is 790 mm. The tool was used in the work until its working length was reduced approximately to 250 mm. Such exploitation tool is possible only if the tool does not break somewhere in the middle part (Fig. 1.26) before its maximum wear along the length [18].

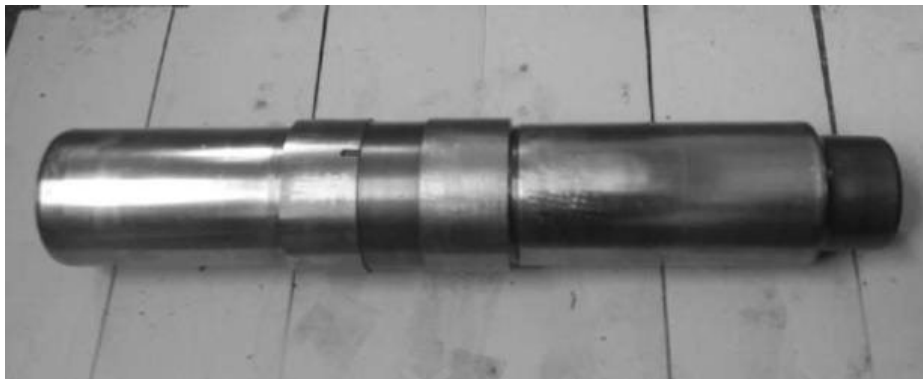
Figure 1.30. The striker hydraulic hammer (general view)

The striker is the main element of the hammer. The striker is a certain mass m that must be moved some distance from the tool and accelerated to a given speed V towards the tool. In order to accelerate the striker to the desired speed, To him need to attach corresponding strength, the value of which is determined by the pressure of the working fluid and the area on which this pressure acts, as well as the gas pressure in the pneumatic chamber and the corresponding area of the end of the striker on which the gas pressure acts.

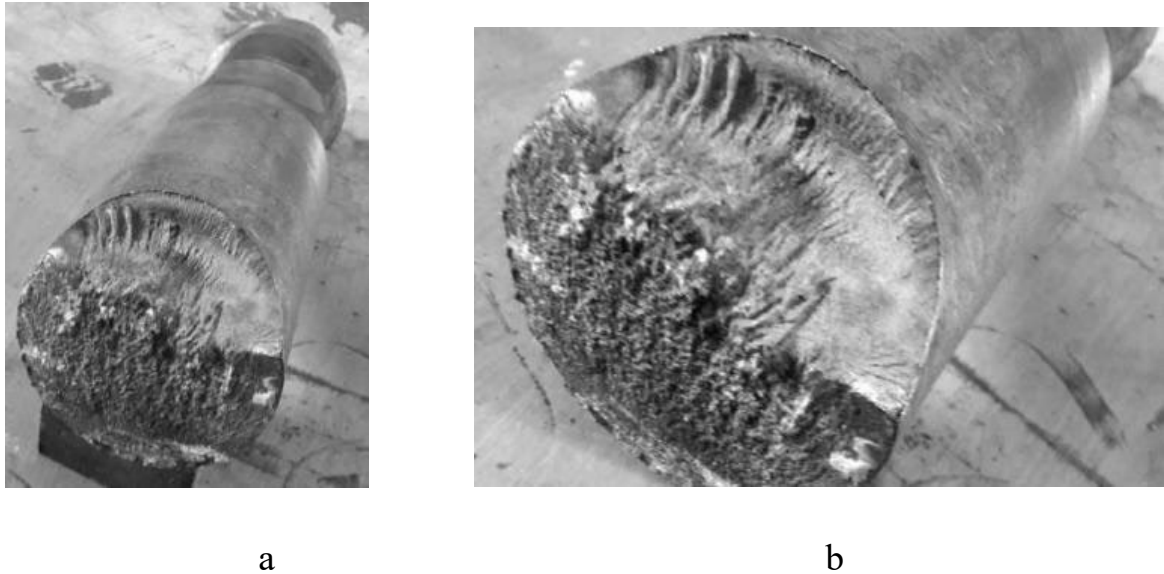
Figure 1.31. Fatigue destruction striker hydraulic hammer during operation

One of the reasons for the destruction of strikers is metal fatigue (Fig. 1.31).

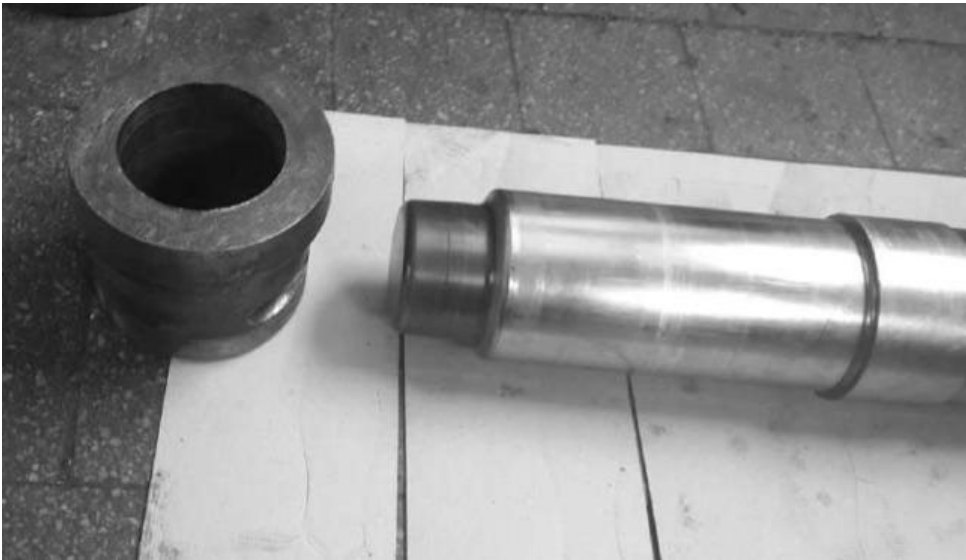
Figure 1.32. The striker and bushing

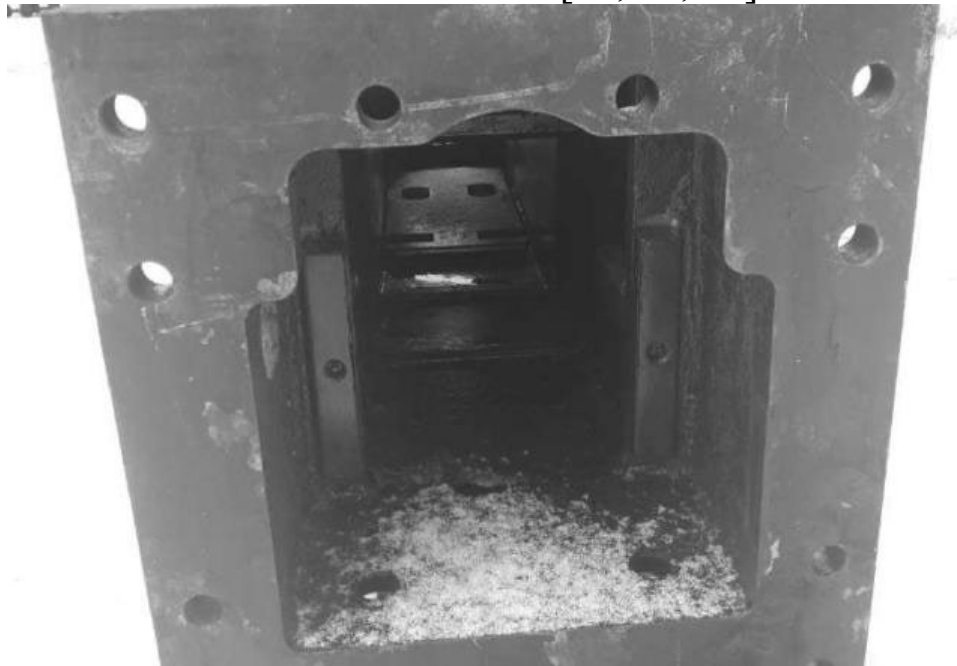
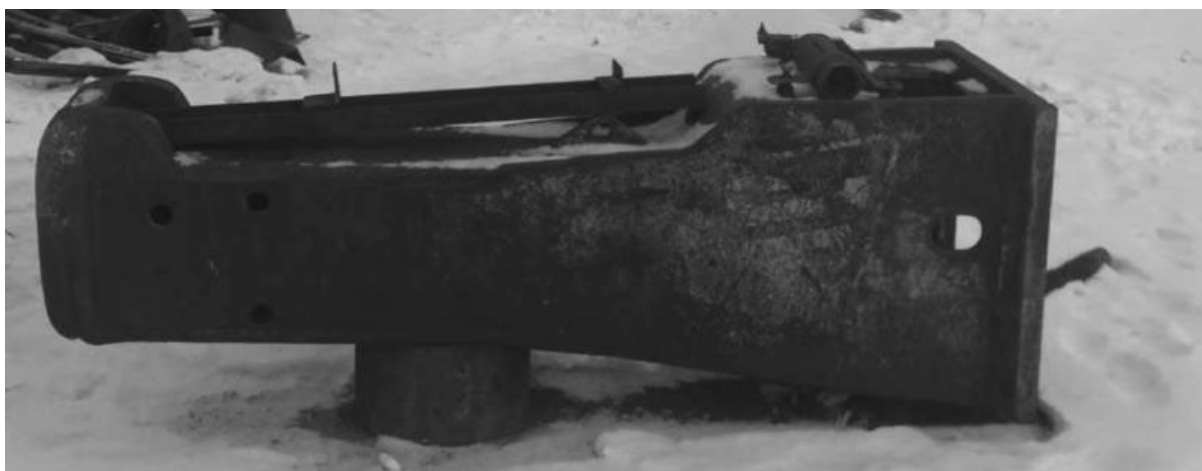
Figure 1.36. Casing (frame) hydraulic hammer after exploitation

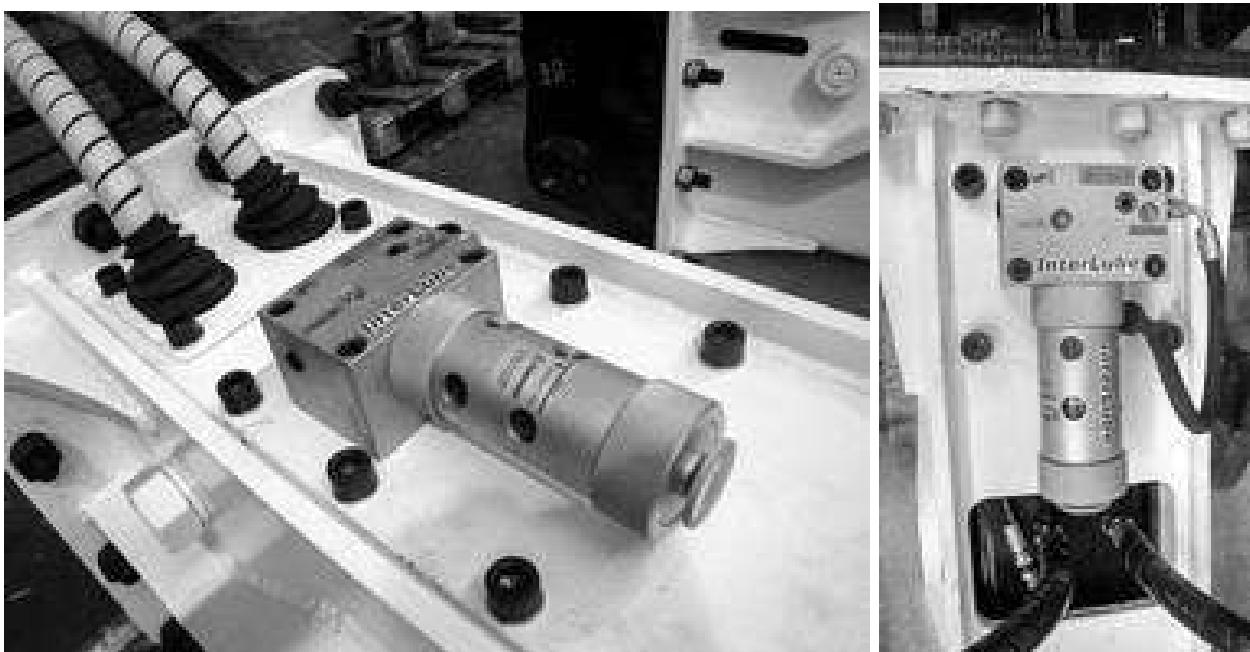
Figure 1.37. System automatic lubricants For hydraulic hammer [35]

Availability at hydraulic hammer systems automatic lubrication will not only allow you not to involve the excavator operator in the work, but will also ensure uninterrupted lubrication of the rubbing units exactly at the moment when it is really necessary. As a result, the time for equipment maintenance is reduced, the service life of the replaceable parts of the hydraulic hammer (peak, bushing of the working tool) is increased and cases of missing scheduled hydraulic hammer lubrication work. The system (Fig. 1.37) is mounted on the hydraulic hammer body and is independent of the base machine. It is convenient and safe, especially If hydraulic hammer is being exploited on several excavators.

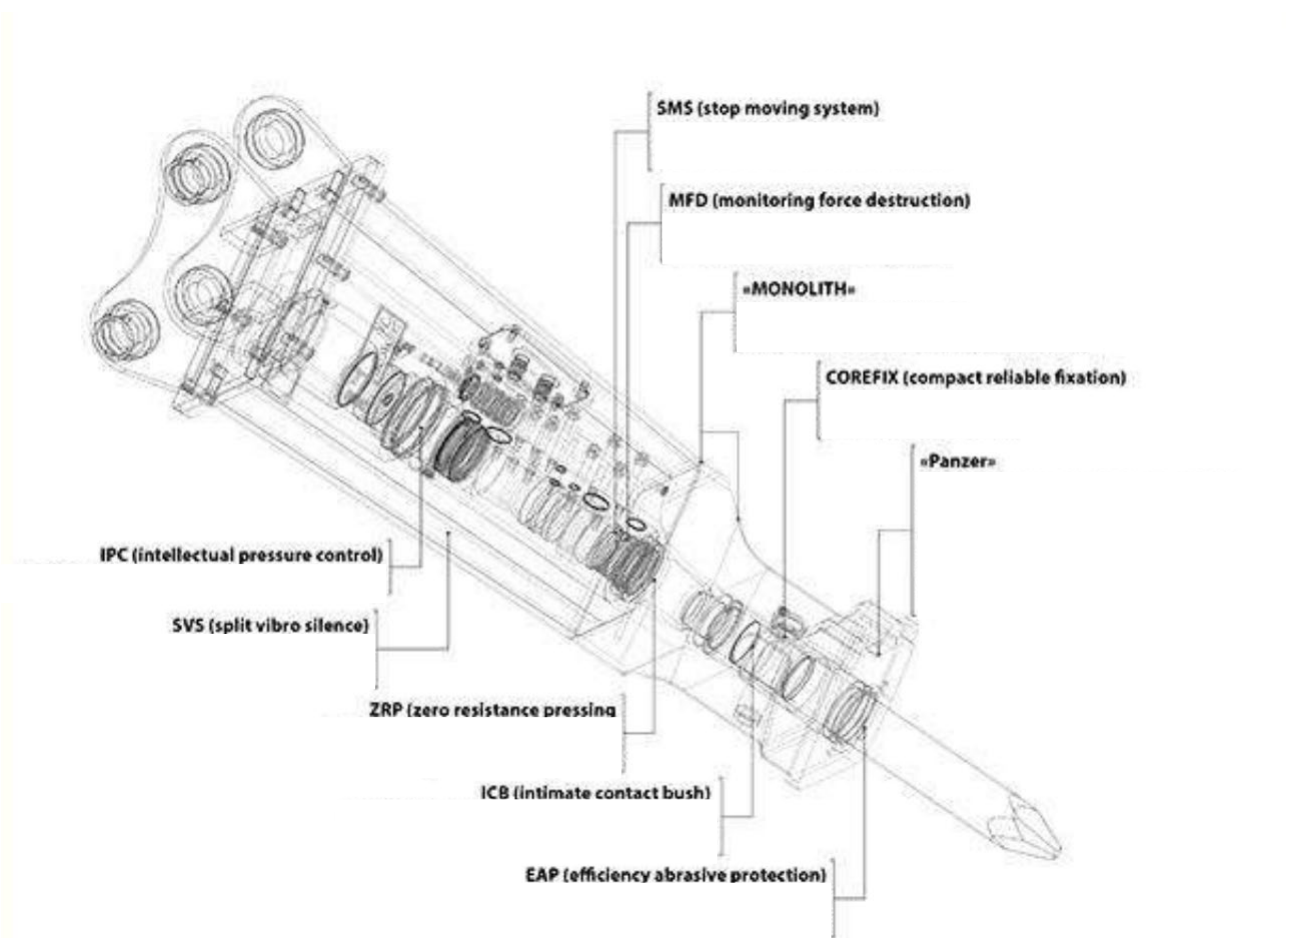
Figure 1.38. Innovations V constructions hydraulic hammer [36]

The Delta hydraulic hammer range has recently been expanded with the Delta F-12 Full Hydraulic hammer in a noise and vibration-proof design [36]. IN Delta F-12 Full Hydraulic present record for the industry, the number of innovations that bring it to the same level as the products of such famous brands as Hammer (Finland), Atlas Copco (Sweden), Montabert (France), and other leaders in the global destructive manufacturing industry attachments.

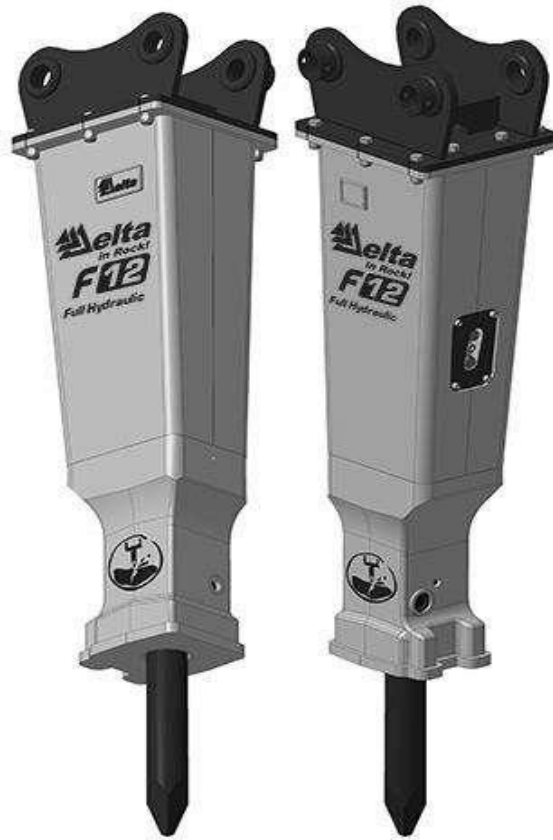
Figure 1.39. Hydraulic hammer Delta F-12 Full Hydraulic, equipped energy accumulator With system IPC [20]

It can be said that the automatic adjustment system itself adjusts the pressure in the accumulator, correlating it with the current characteristics of the drive circuit of the base machine and equalizing it to the required value. This operating algorithm leads to the greatest productivity and significantly reduces the load on the components of the excavator hydraulic system. Since this system does not require maintenance, downtime in operation is eliminated, service costs are reduced. The innovation also makes it possible to operate the hydraulic hammer in the harshest climatic conditions, down to -50°C , without the risk of damage to parts. and the use of additional options, which is an important parameter. The design of the striker is developed taking into account the features of difficult operating conditions of the equipment. The cylinder, made of a special alloy, is processed by the method of chemical-thermal ion-diffusion nitriding. All changes are made to ensure high reliability, wear resistance when working in contaminated environments, and reduce the requirements for storing the hydraulic hammer [18–20].

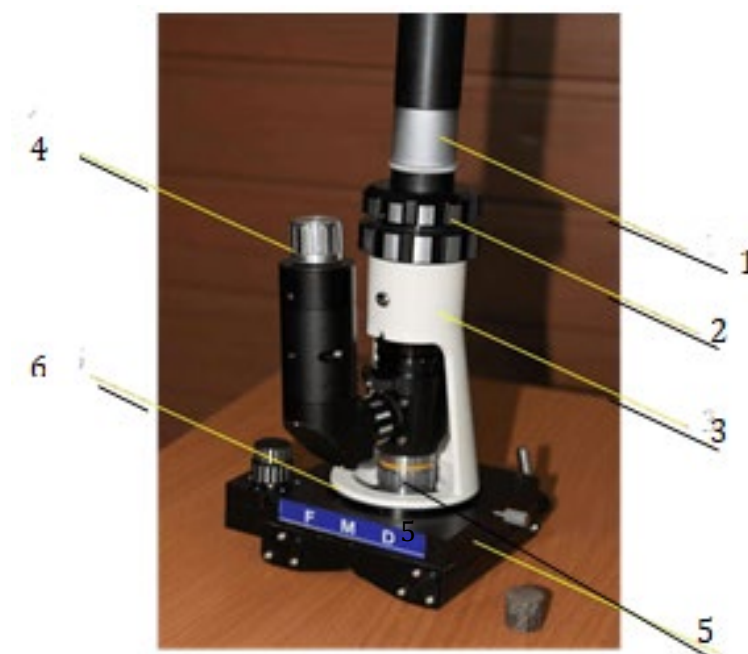
Figure 2.1. General view of the Altami-MET1 microscope: 1 – eyepiece; 2 – focal length screw; 3 – tube; 4 - backlight; 5 - lens; 6 - magnetic table [37]

The professional metallographic microscope Altami-MET is indispensable for work in stationary and field (portable modification P) conditions. It allows for the examination of any opaque objects located at any angle to the horizon [37].

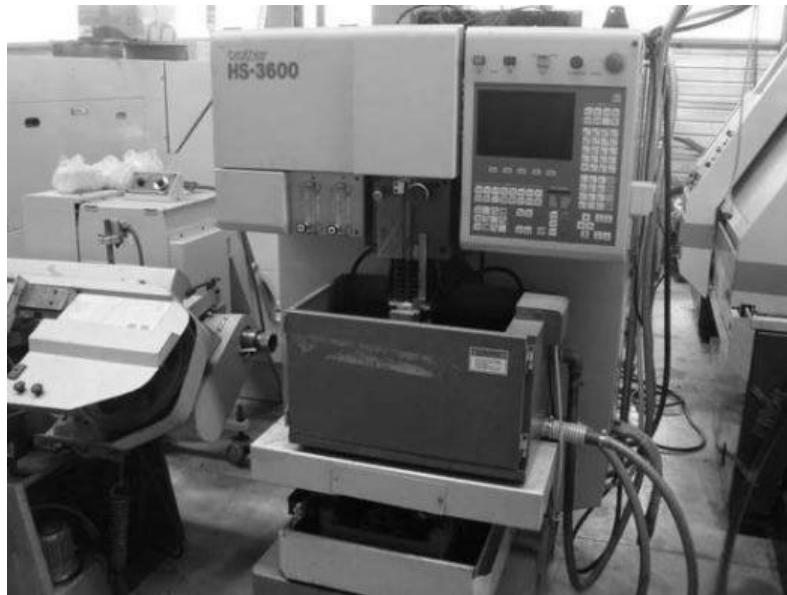
Figure 2.14. Modern galvanic bath [106]

In chromium plating, anodes made of pure lead or lead alloy with 4-6% antimony were used. Anodes are made of rods with a diameter of 10-15 mm or sheets. The ratio between the surface of the anodes and cathodes should be within the range of 1:2 to 2:3. Lead anodes are covered with a layer of lead chromate during operation, which makes work difficult. Therefore, it is recommended to clean them daily with steel brushes. In between work, the anodes are removed from the bath and immersed in water.

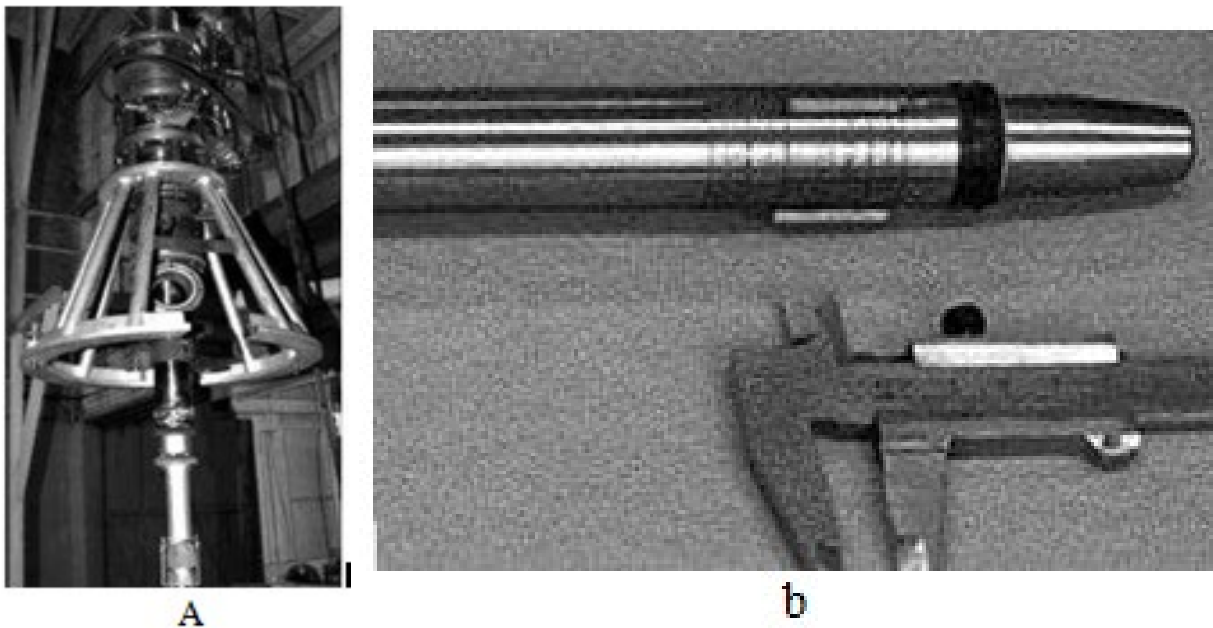
Figure 2.14. Radial-type electric arc evaporator of metals with a movement mechanism (a); devices and sources of metal ions with a diameter of 20 mm (b) [114]

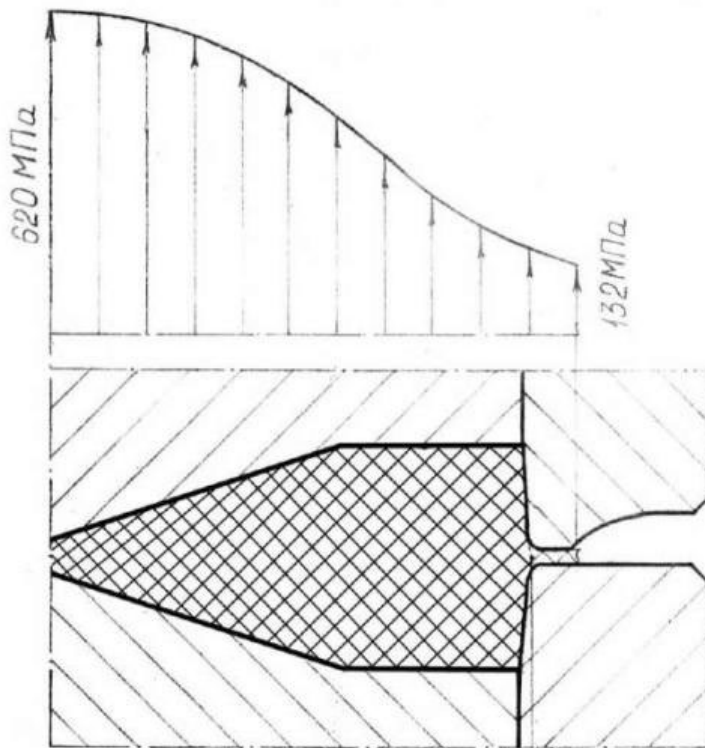
Figure 2.18. Epura distributions pressures V cavities of a hydraulic hammer during testing

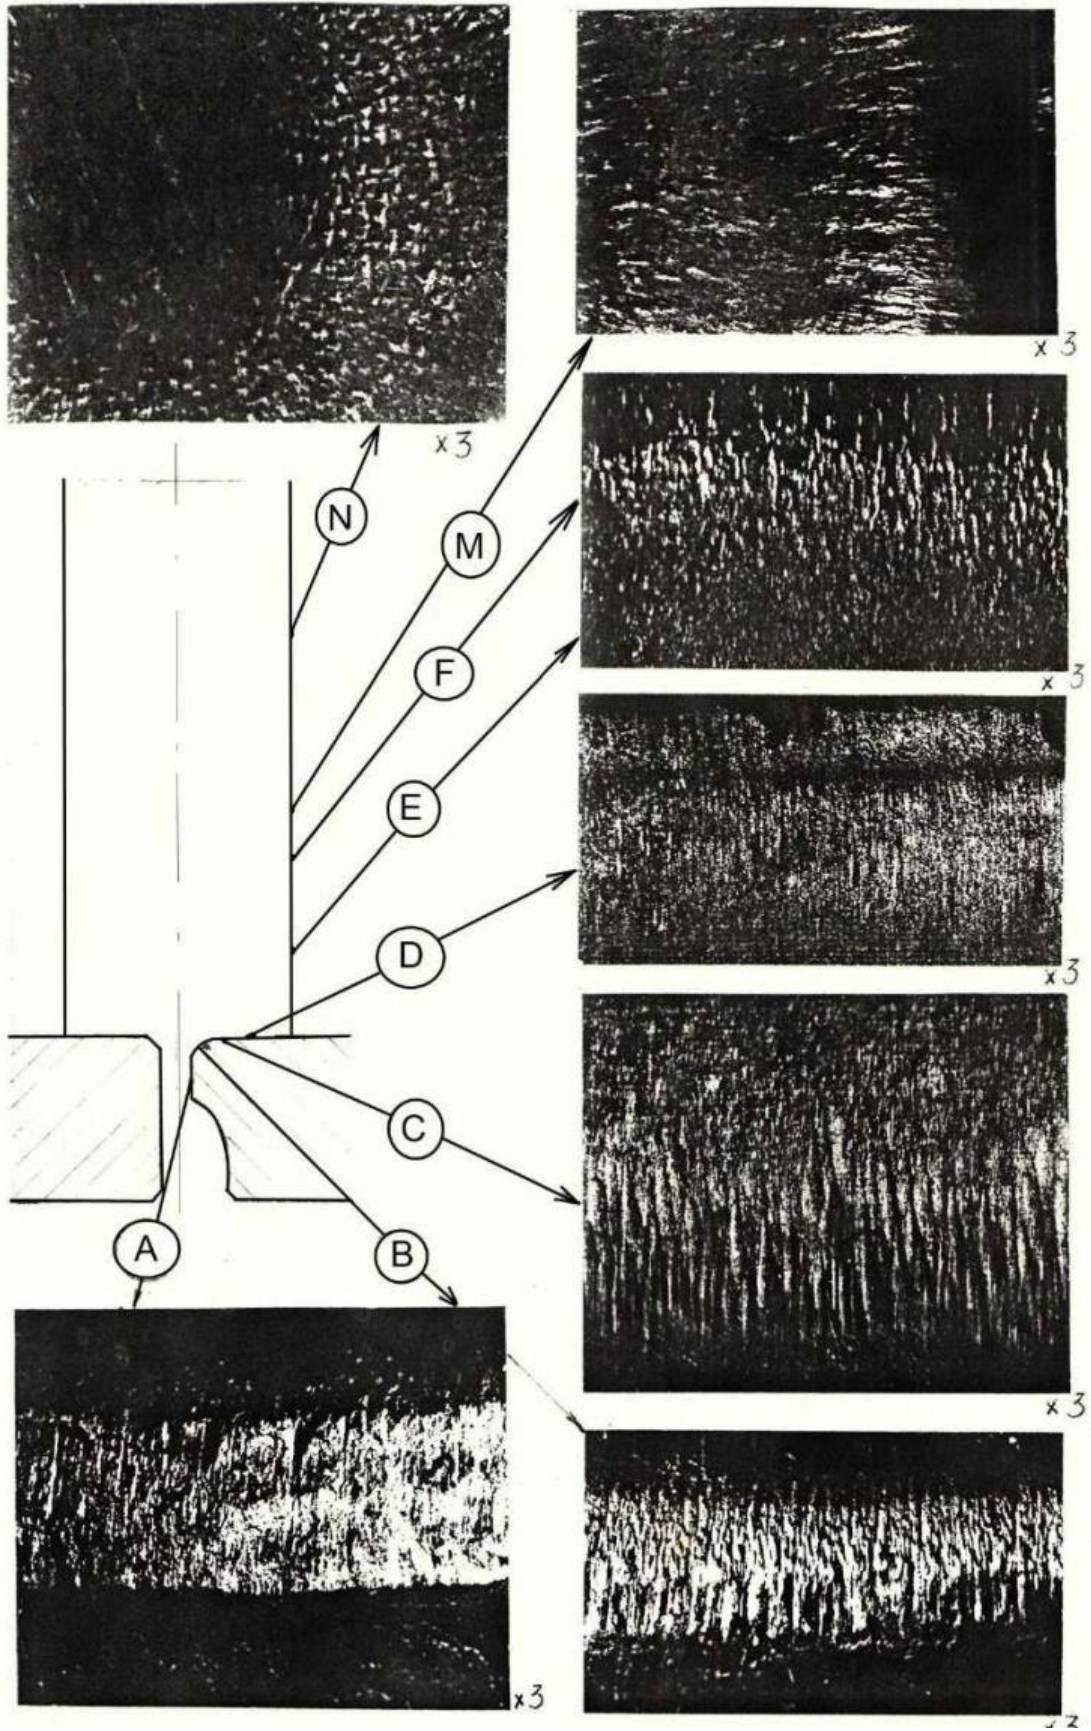
Figure 3.1. Character damage surfaces of the body and striker

The test was carried out until wear patterns on the surfaces of the housing and bushing channels appeared in zones “C” and “D”, similar to that obtained when testing parts manufactured without additional strengthening (see Fig. 3.1 and Fig. 3.2).

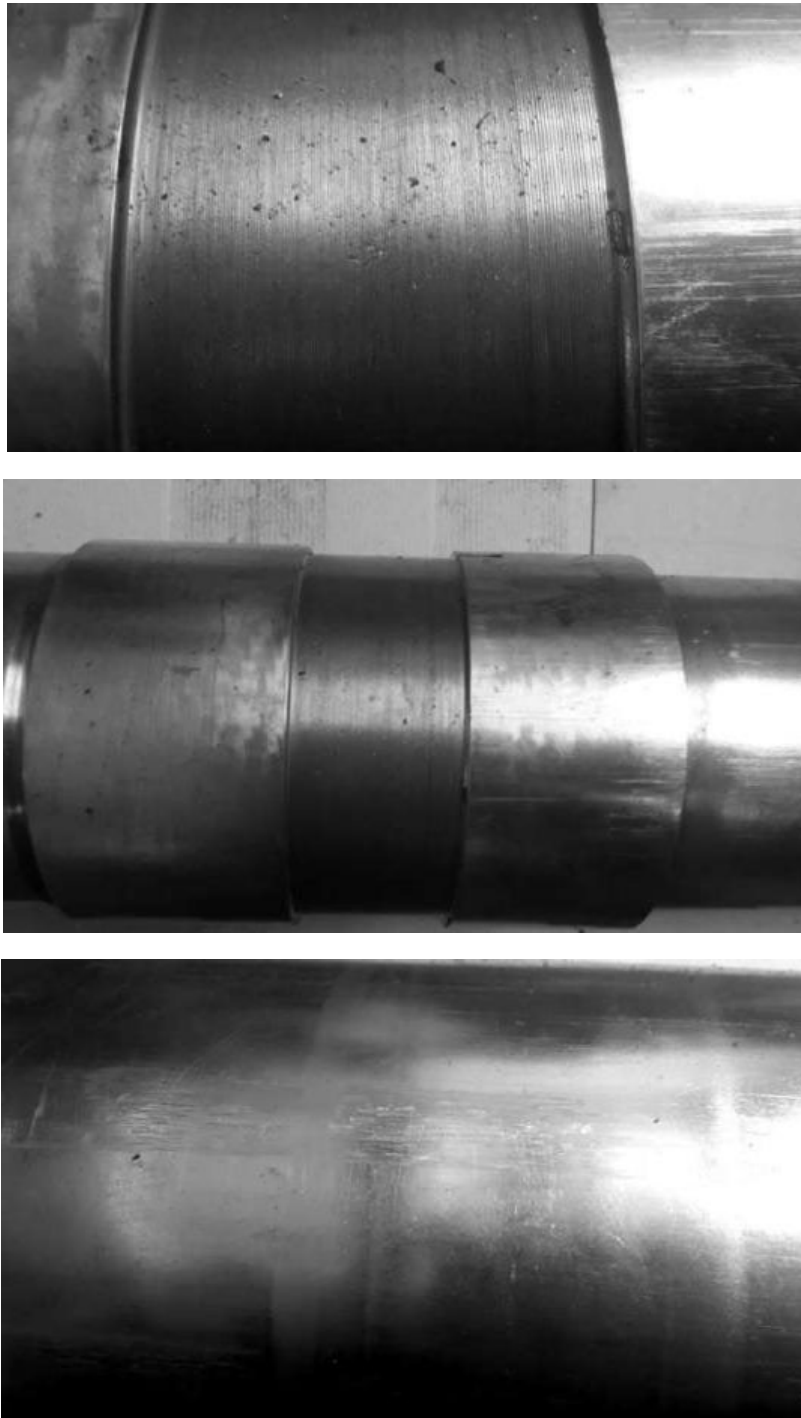
Figure 3.3. The striker after operation: wear surfaces

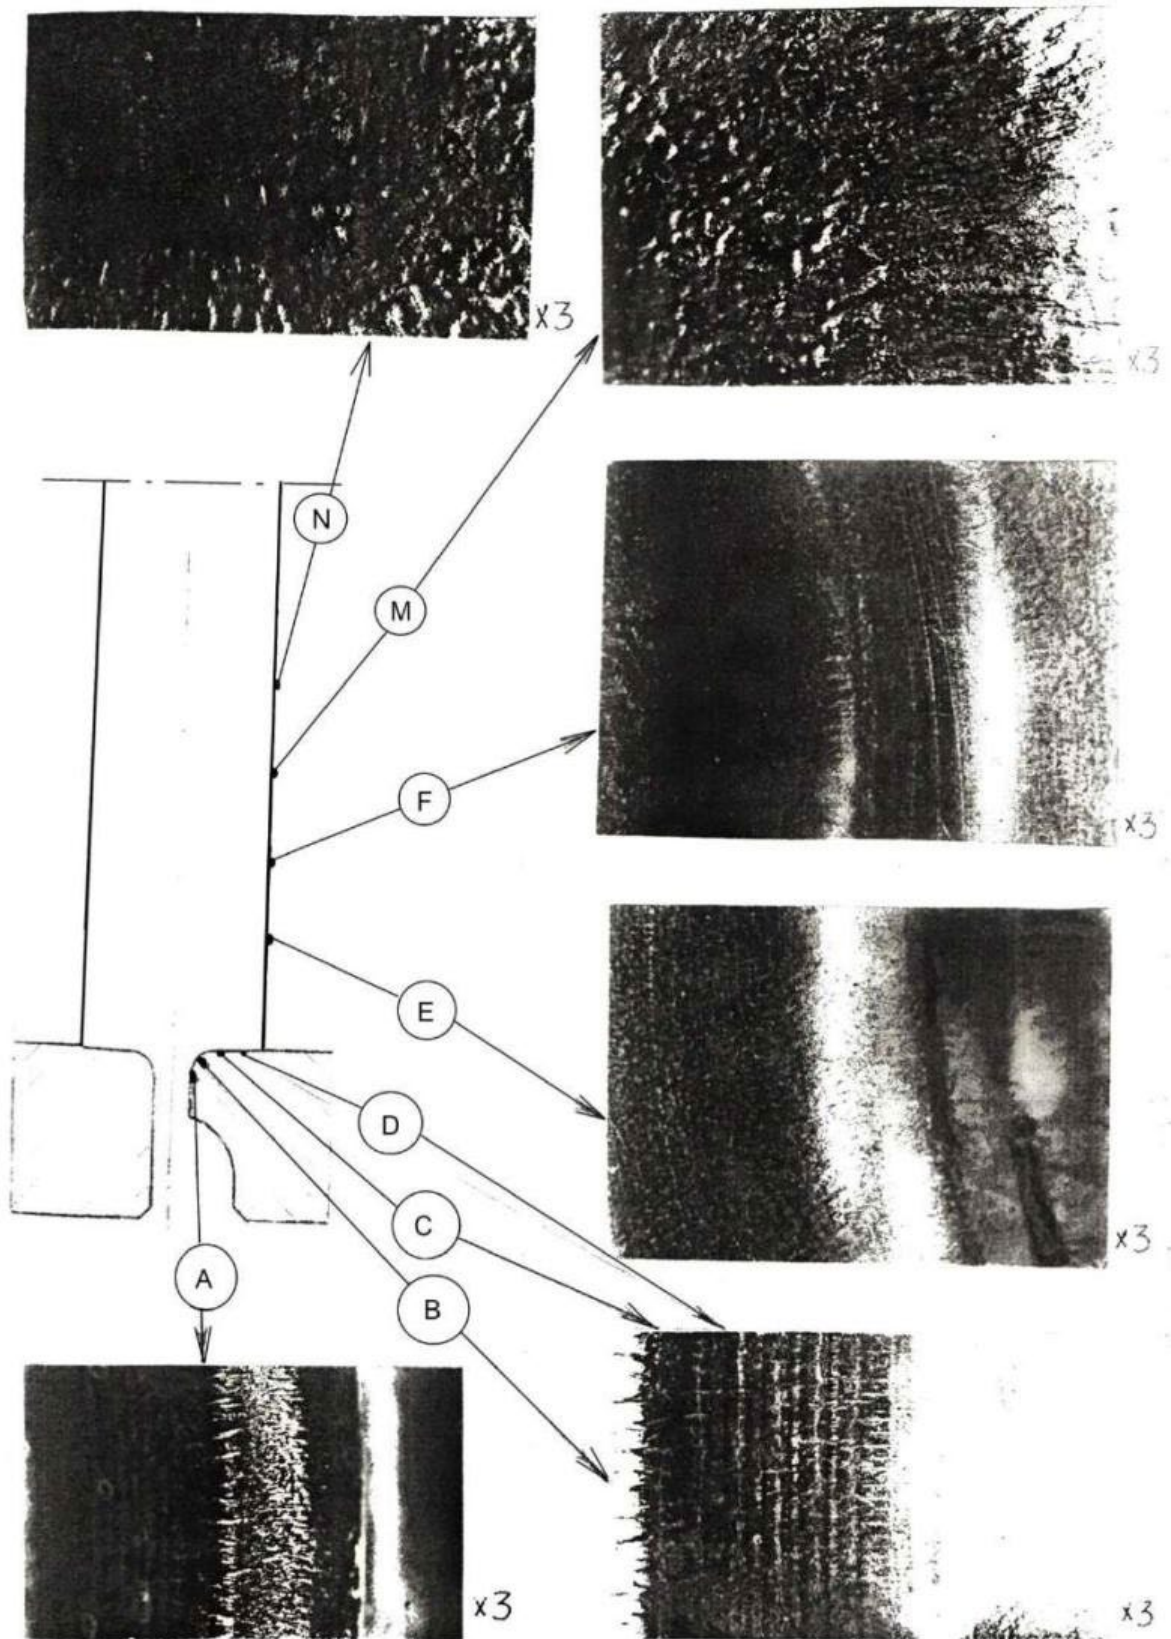
Figure 4.4. Damage surfaces corps And striker, hardened LTO

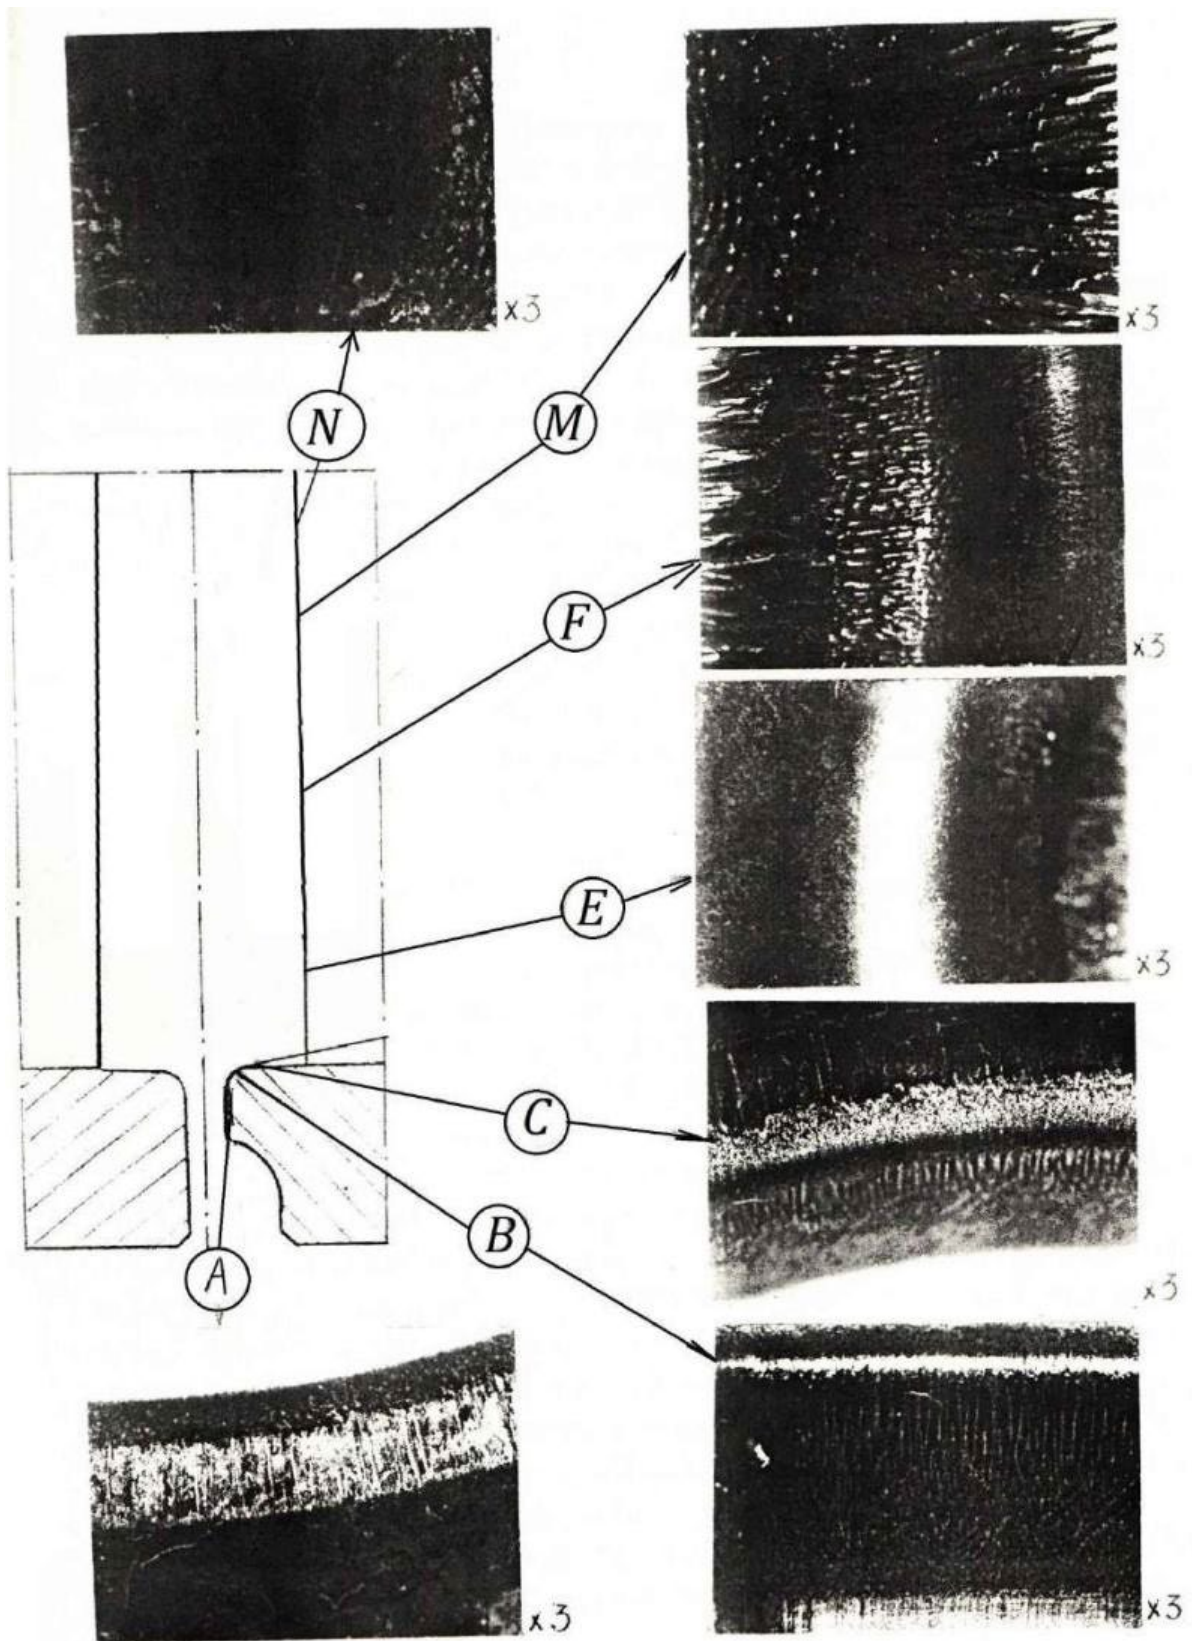
Figure 5.2. Wear corps And striker, reinforced application vacuum plasma carbonitride coating

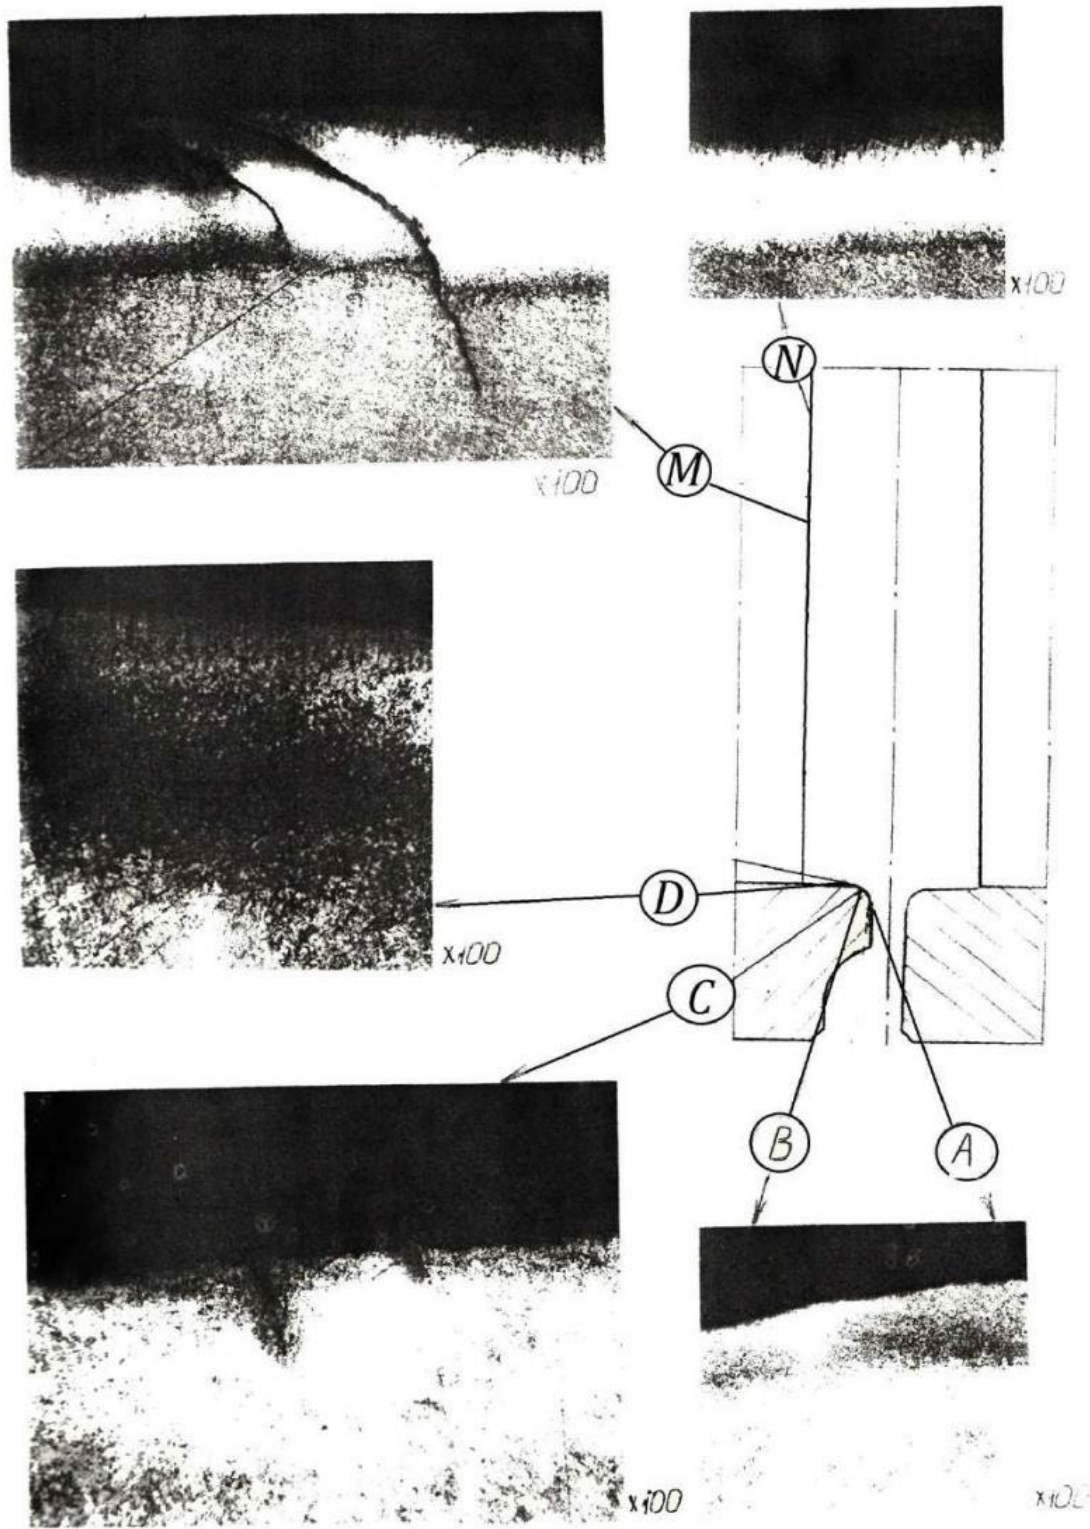
Figure 6.3. Structural changes material corps And striker, reinforced with detonation spraying
