KHARKIV NATIONAL AUTOMOBILE AND ROAD
UNIVERSITY

**TECHNOLOGICAL APPROACHES
TO INCREASE PARAMETERS QUALITIES OF A
HYDRAULIC HAMMER**

Monograph

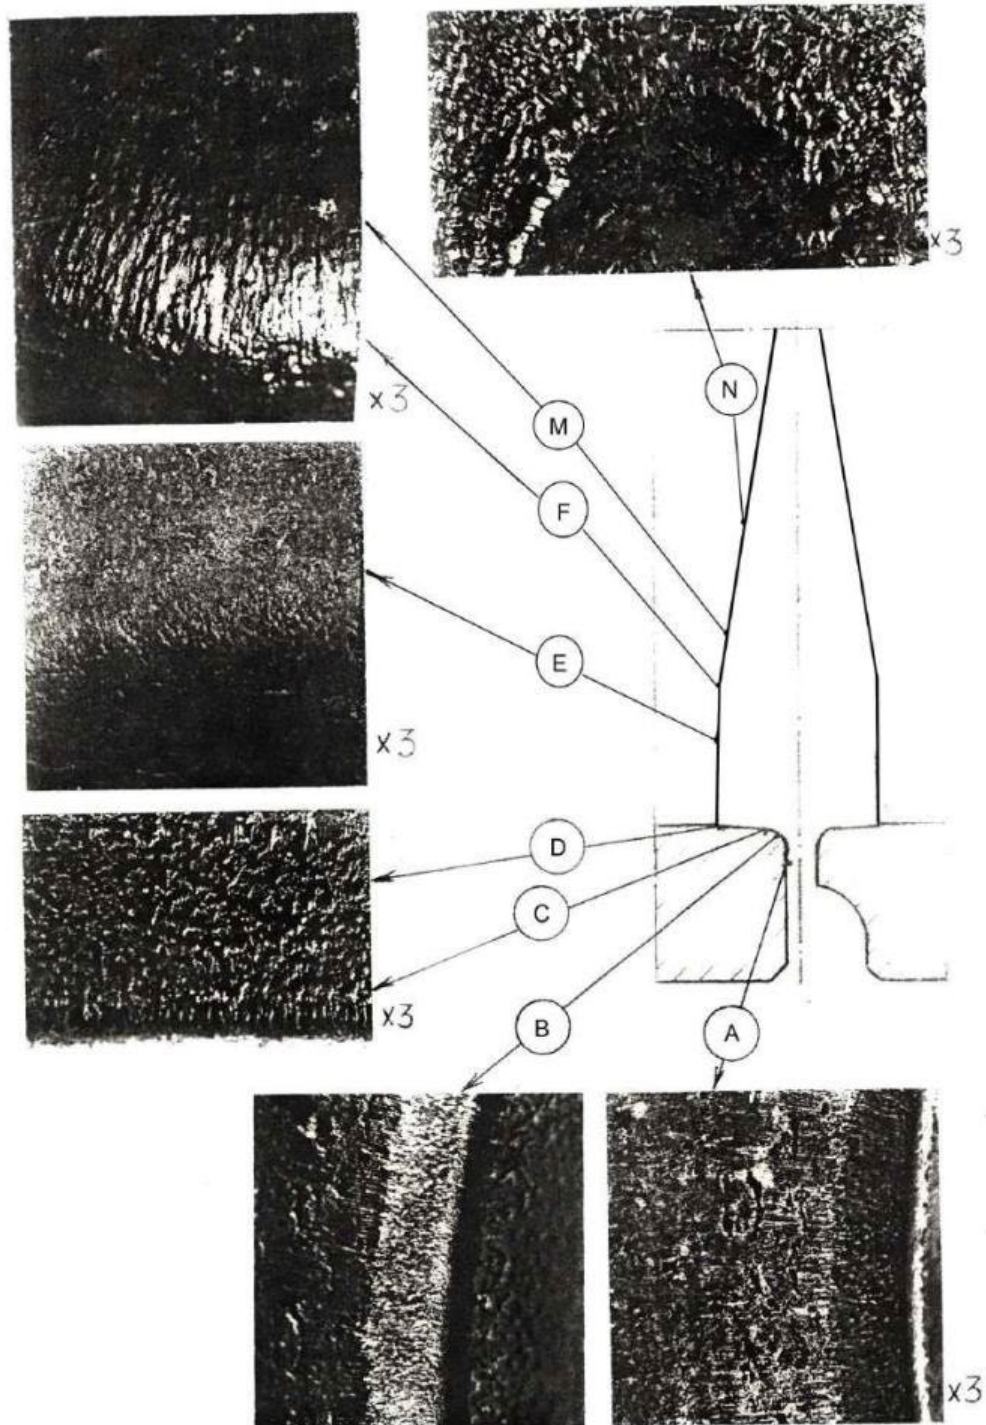
Figure 7.1. Wear peaks And bushings, reinforced EIL

The general appearance of damage to parts hardened by electric spark treatment during testing is shown in Fig. 7.1 and 7.2.

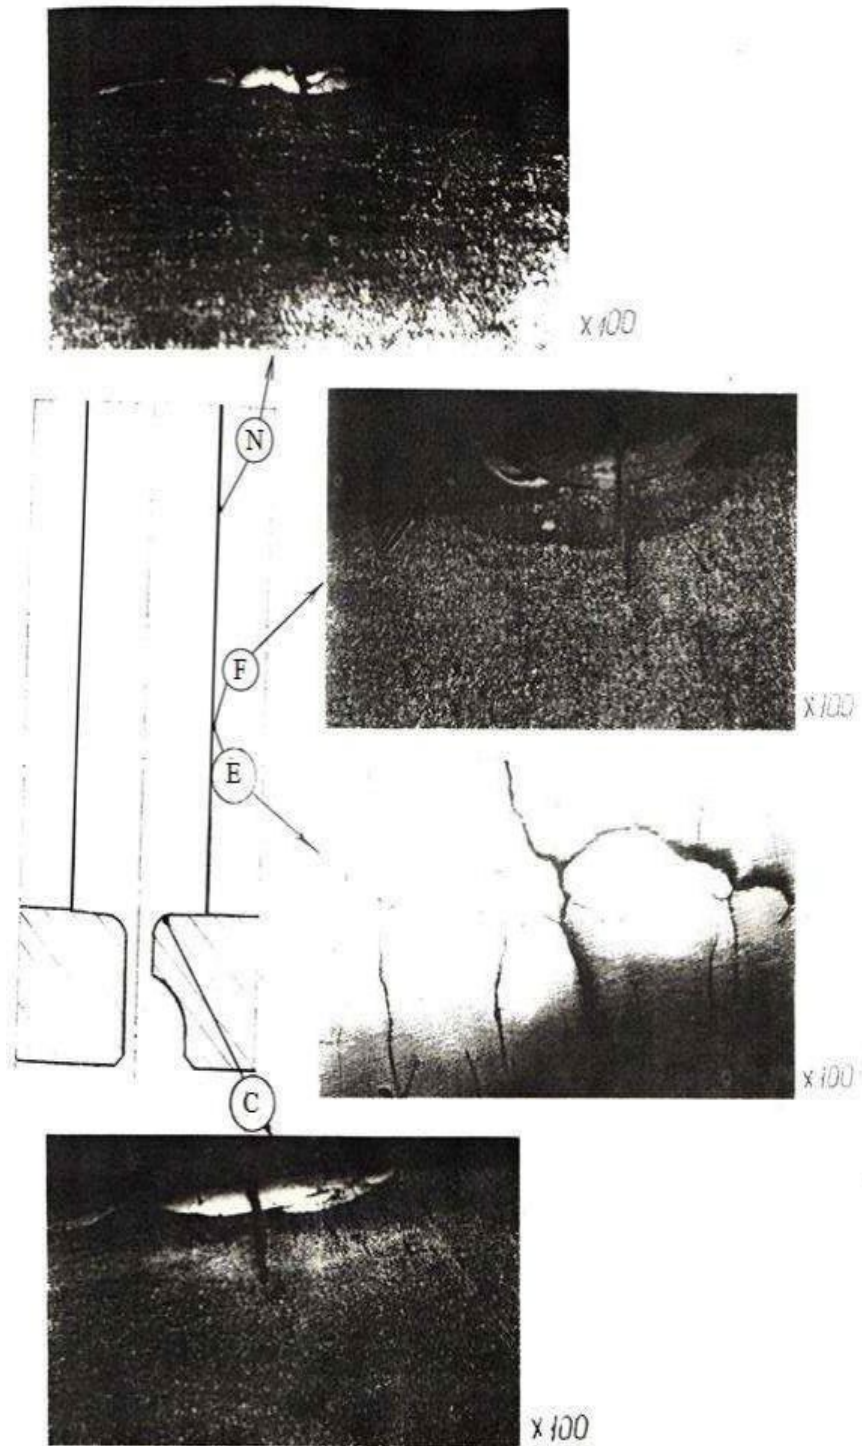
Figure 7.3. Change structures material corps And striker, reinforced with EIL

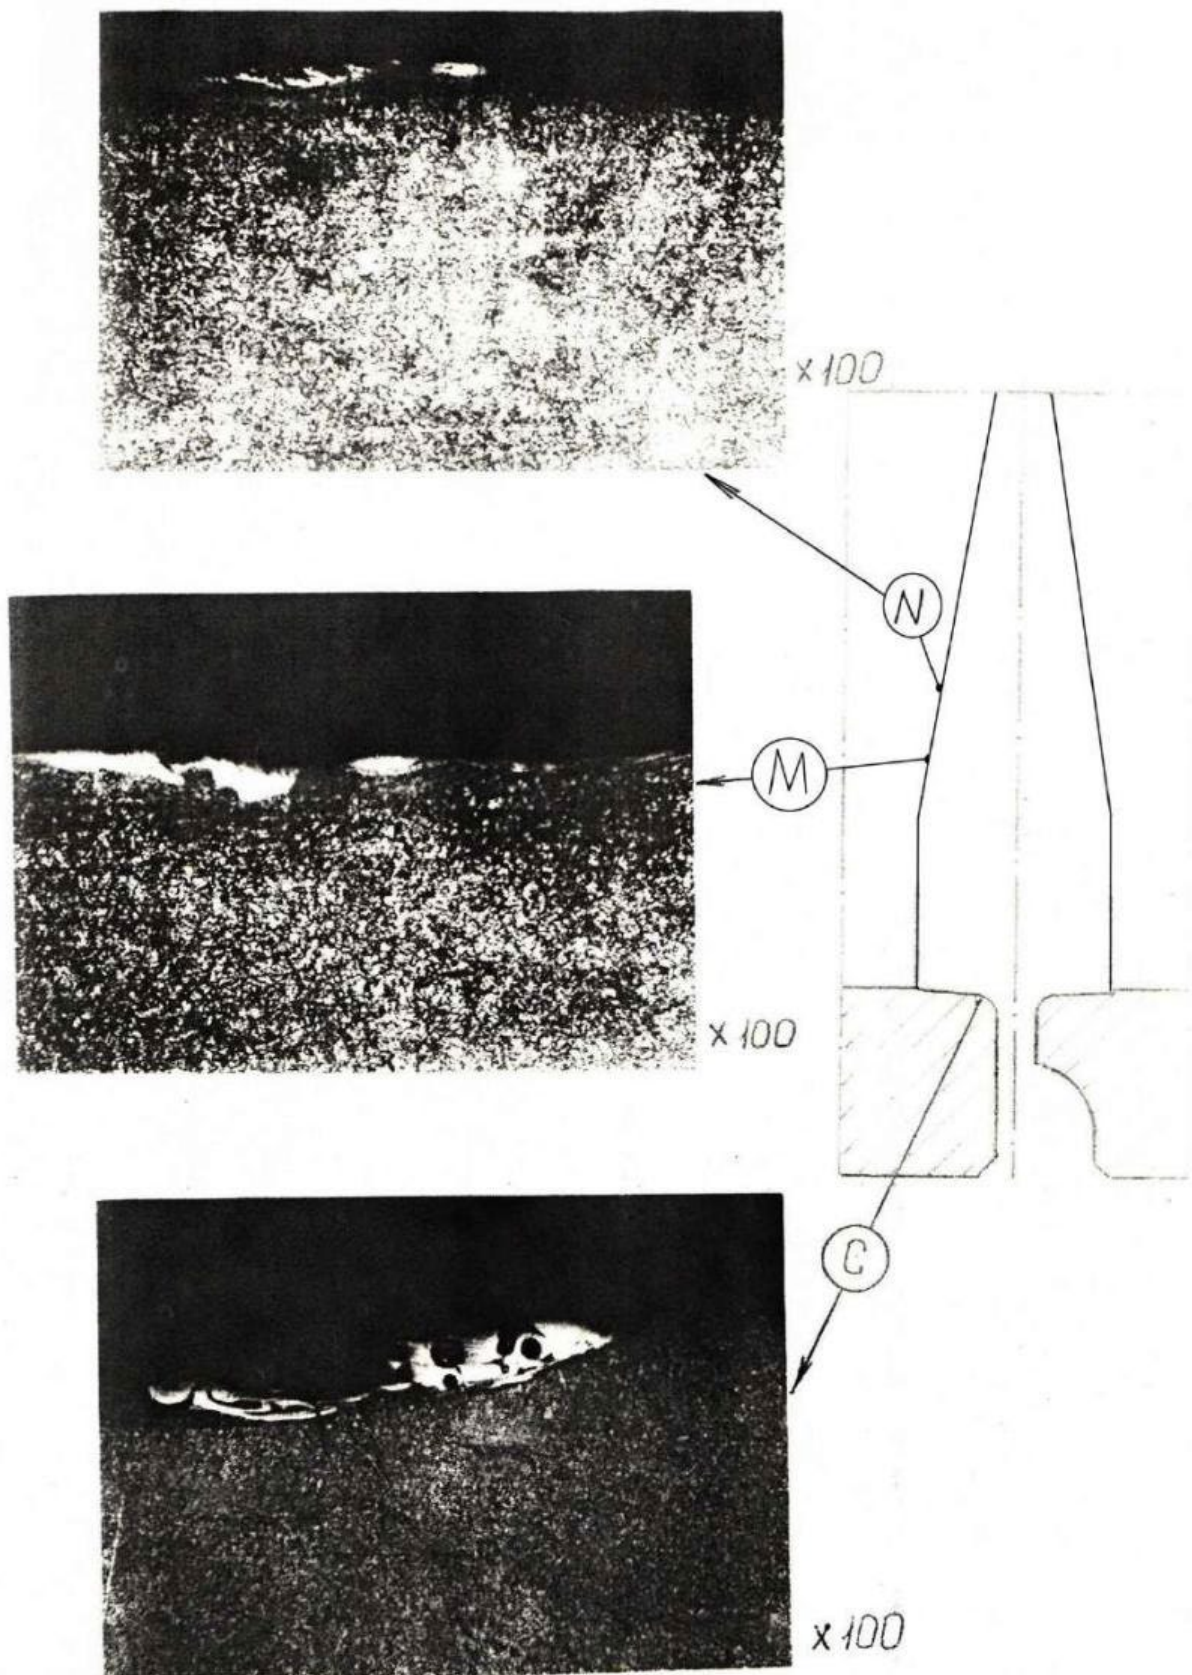
Figure 7.4. Change structures materials peaks And bushings, hardened by EIL

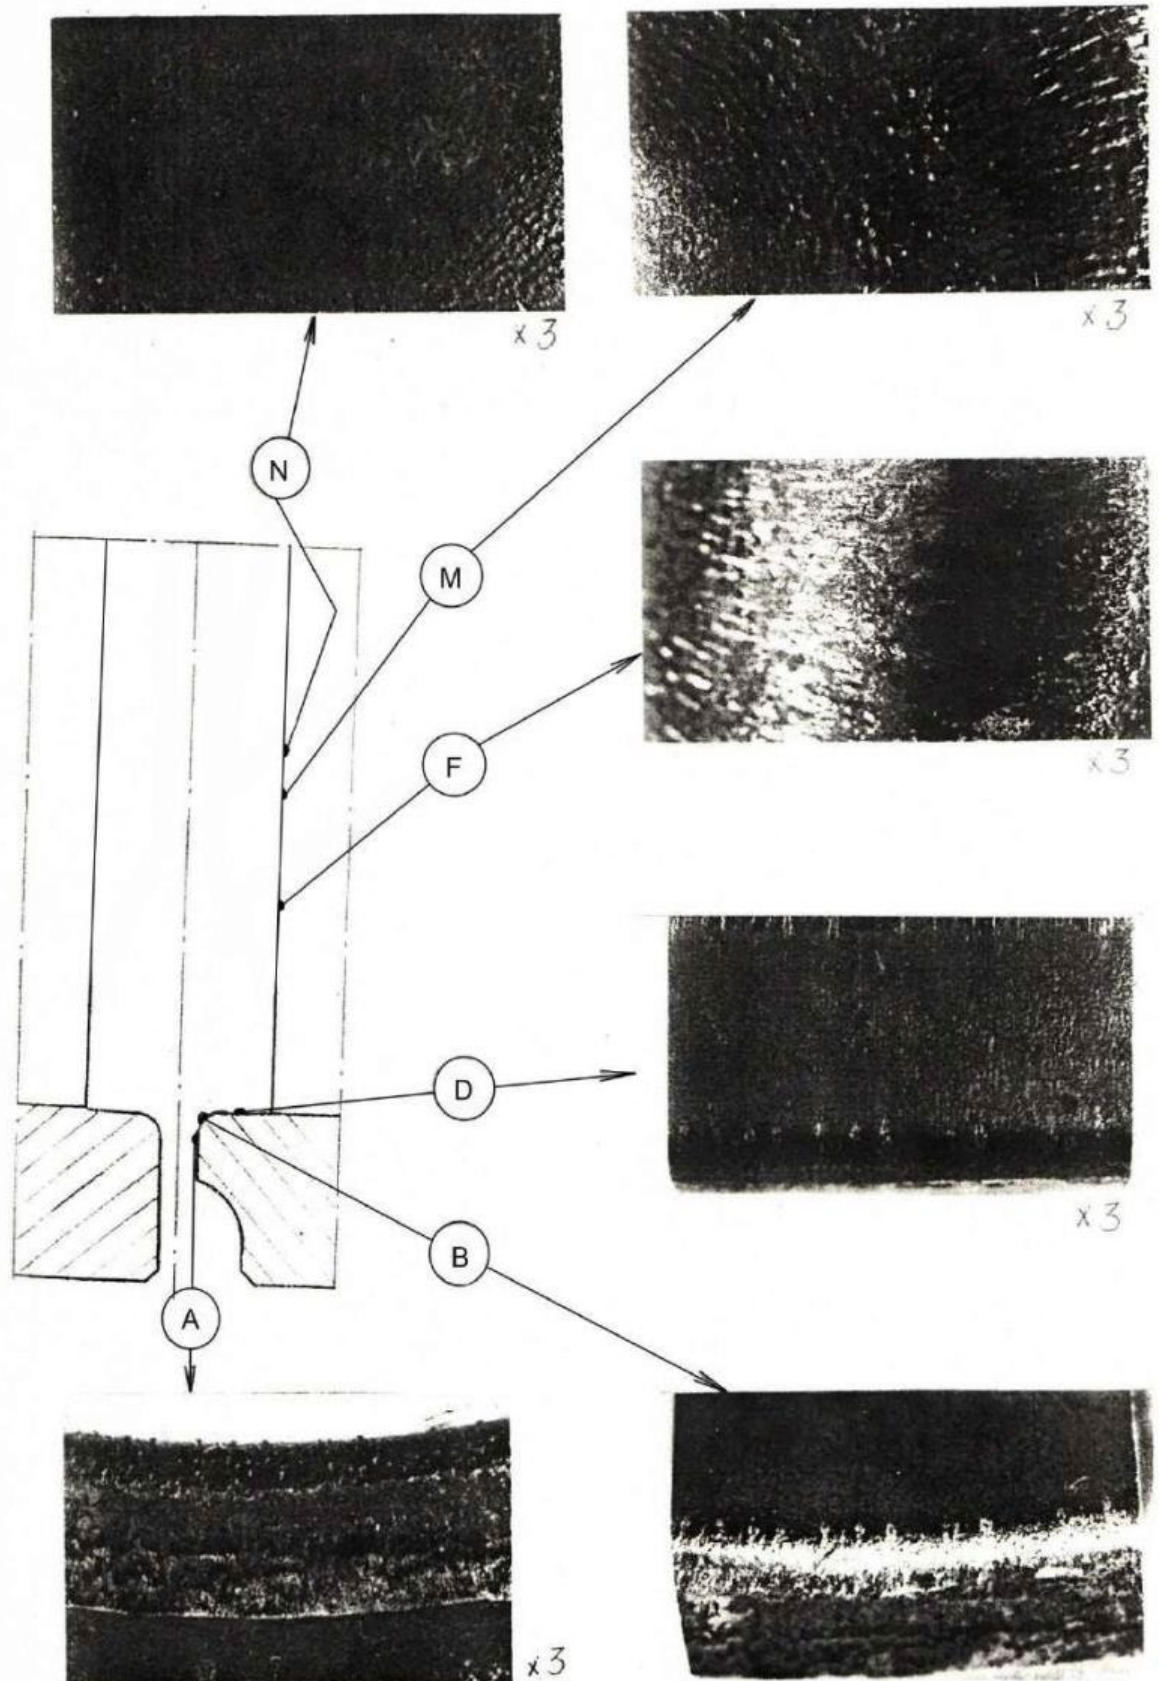
Figure 9.1. Wear corps And striker, reinforced ion plasma chromium plating

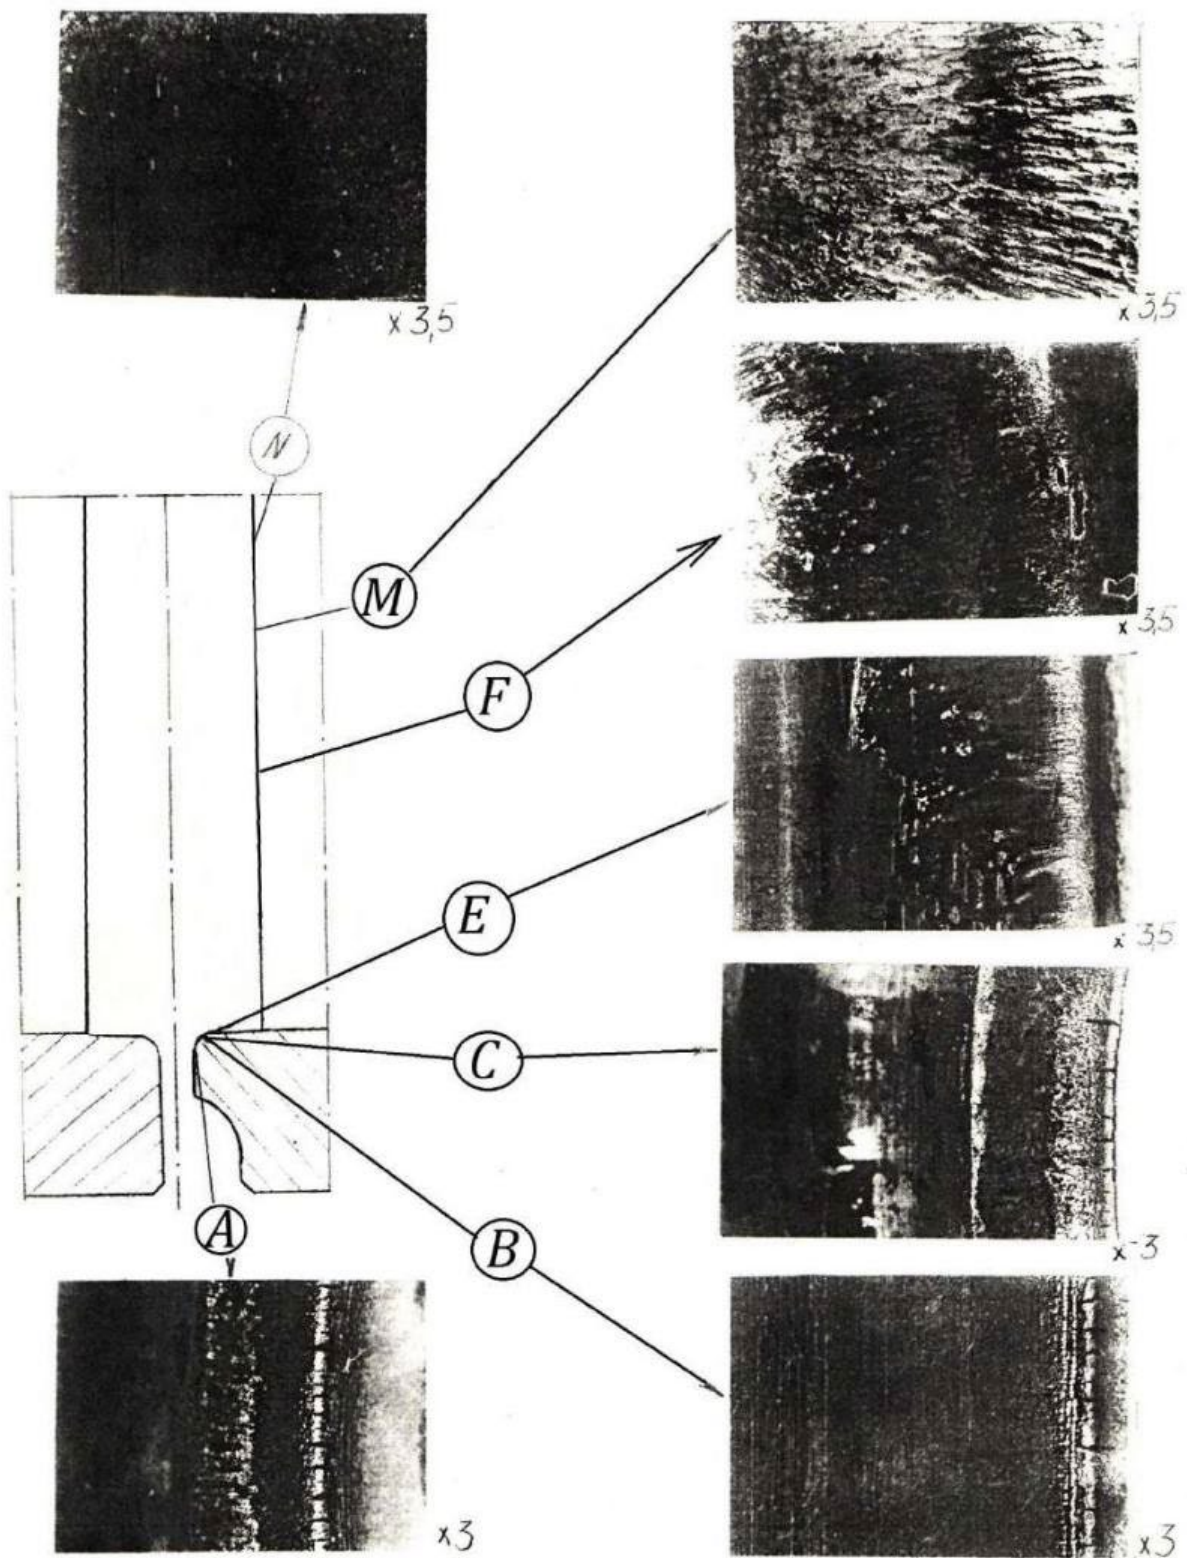
Figure 11.2. Damage corps And striker, reinforced chromium plating by decomposition of the organochromium compound "Barkhos"

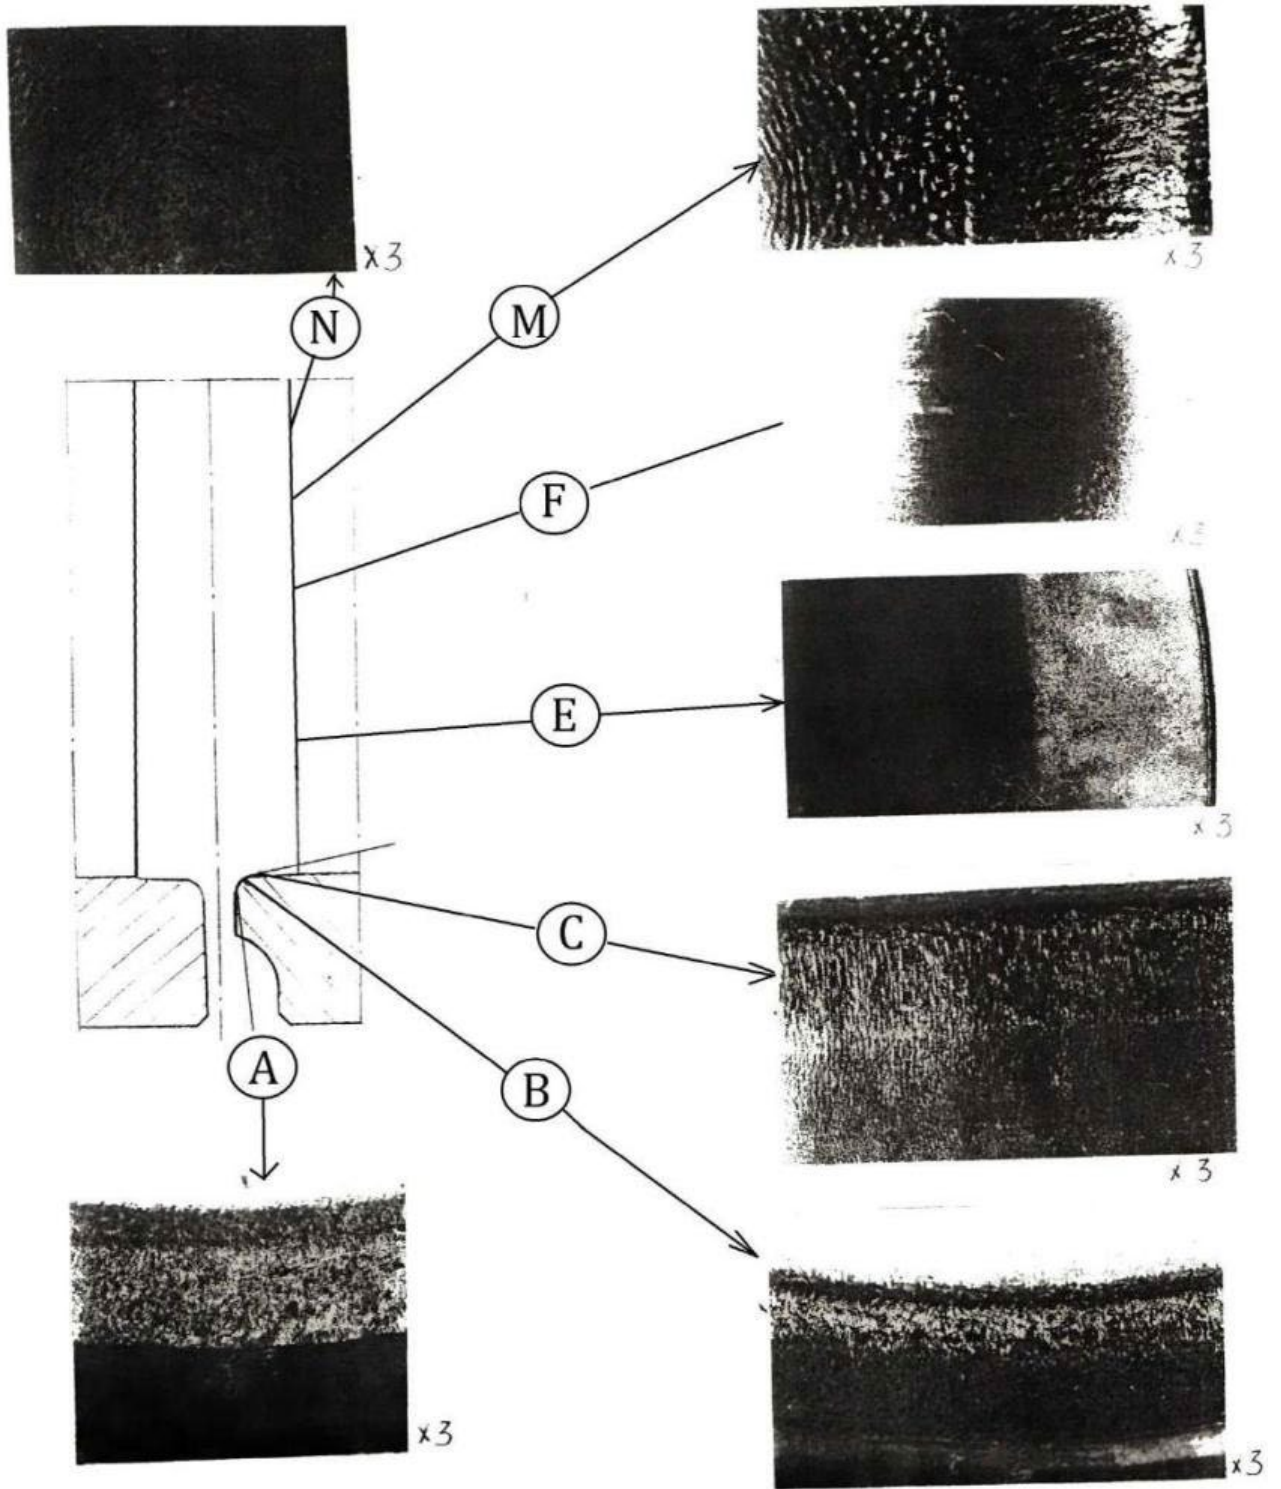
Figure 12.2. Wear corps And striker, reinforced chromium plating using Sumy-Swiss technology

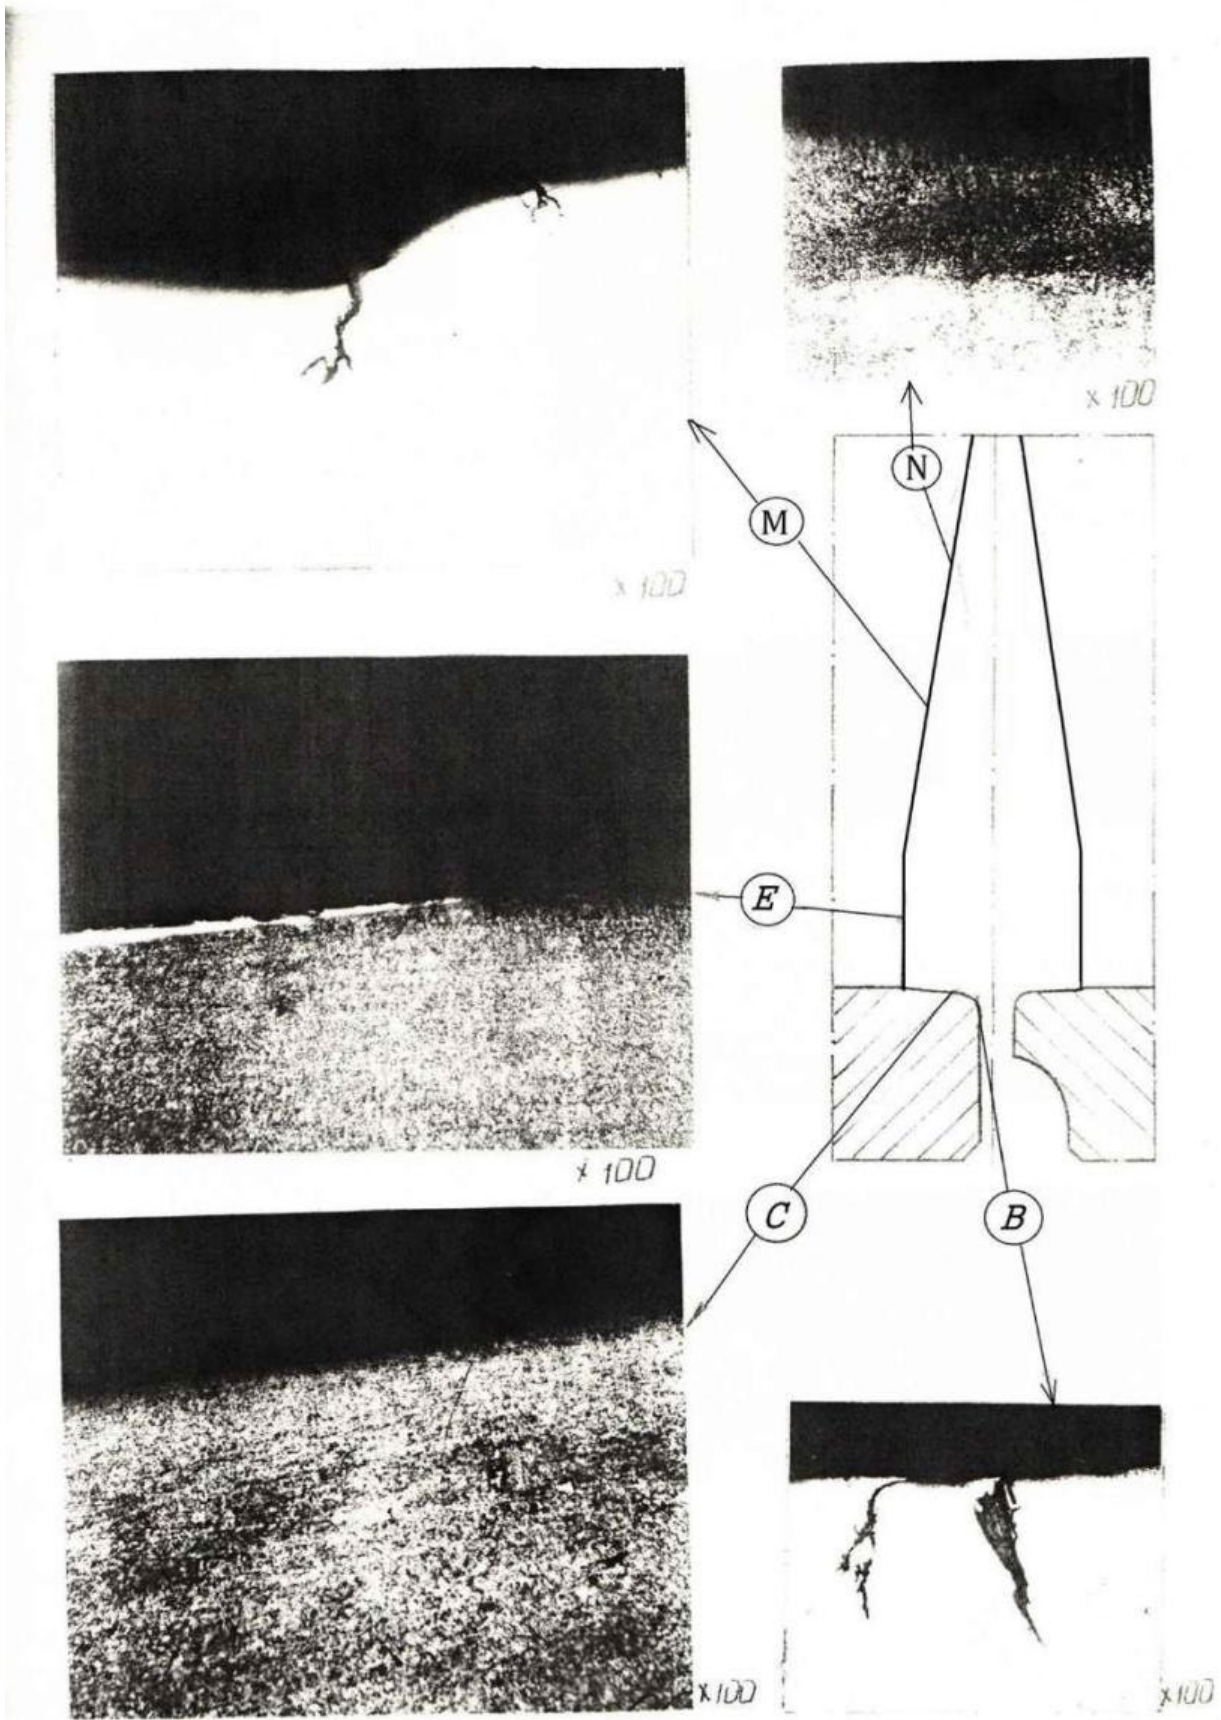
Figure 12.3. Structural changes in the material of the peak and bushing, reinforced chromium plating By Sumy-Swiss technologies

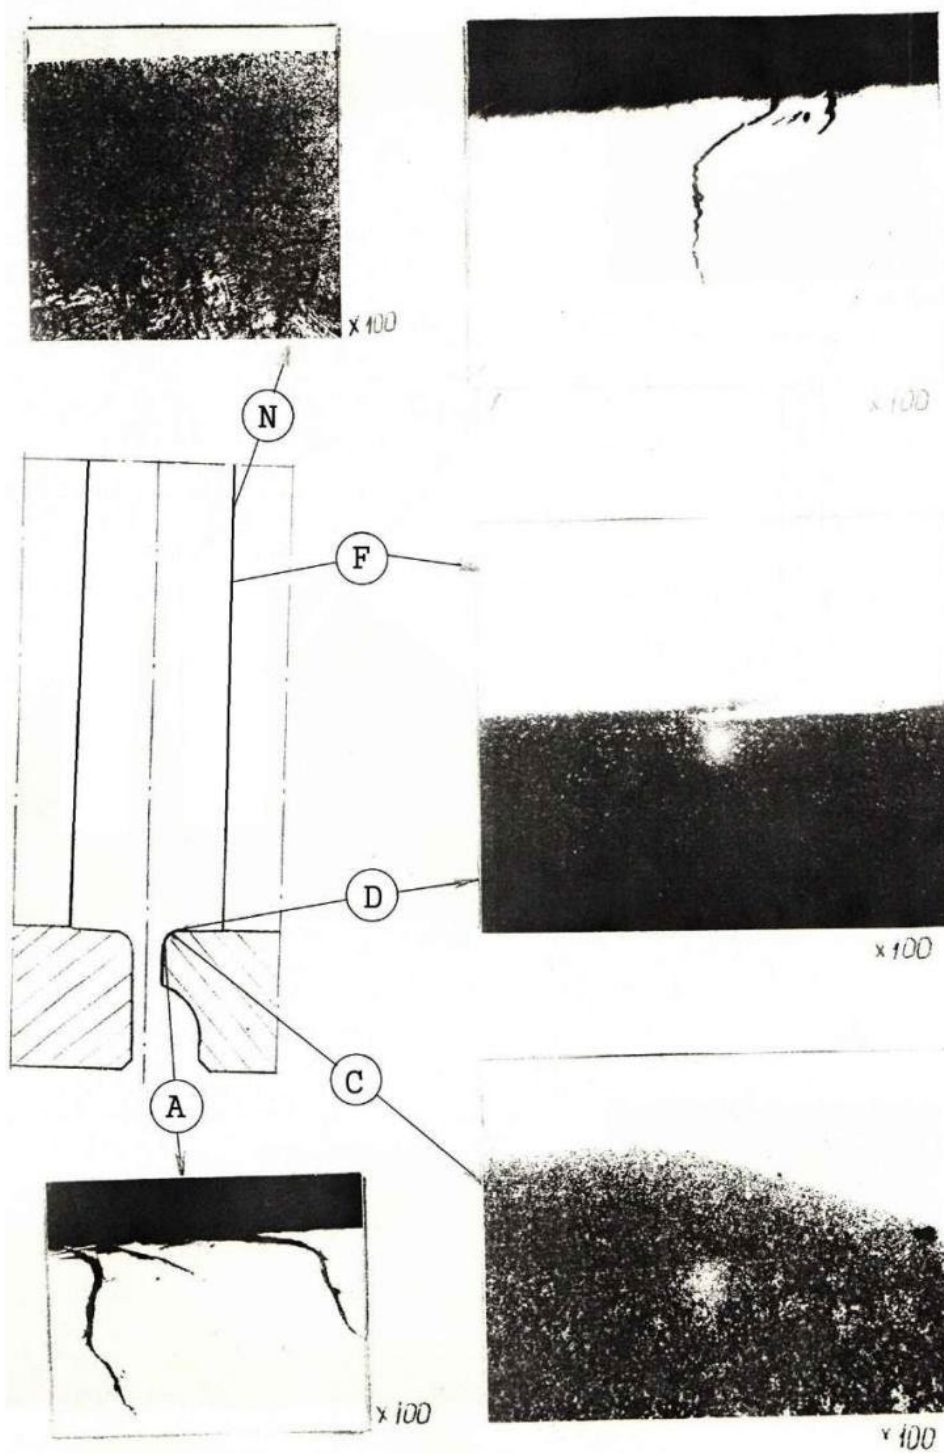
Figure 13.6. Structural changes material corpus And striker, welded with Hastelloy alloy

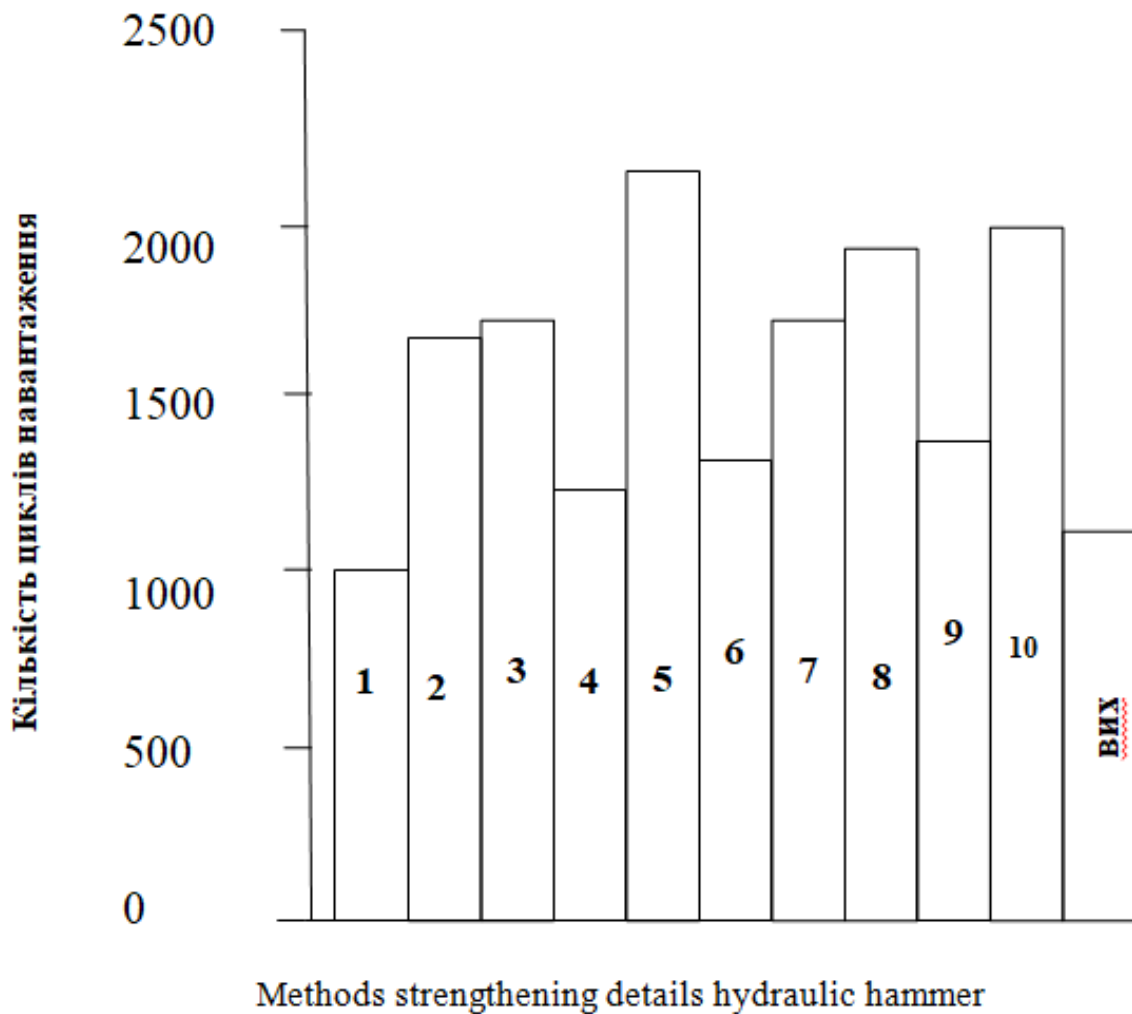
Figure 14.1. Dependence of wear resistance of hydraulic hammer parts on the type of hardening: original – without additional hardening, 1 – ion-plasma chromium plating; 2 – ion-plasma chromium plating using improved technology; 3 – laser heat treatment; 4 – carbonitride coating; 5 – surfacing alloy "Hastelloy"; 6 - electric spark alloying; 7 - detonation hardening; 8 - chromium plating using Sumy-Swiss technology; 9 - chromium plating by decomposition of the "Barkhos" compound; 10 - galvanic chromium plating

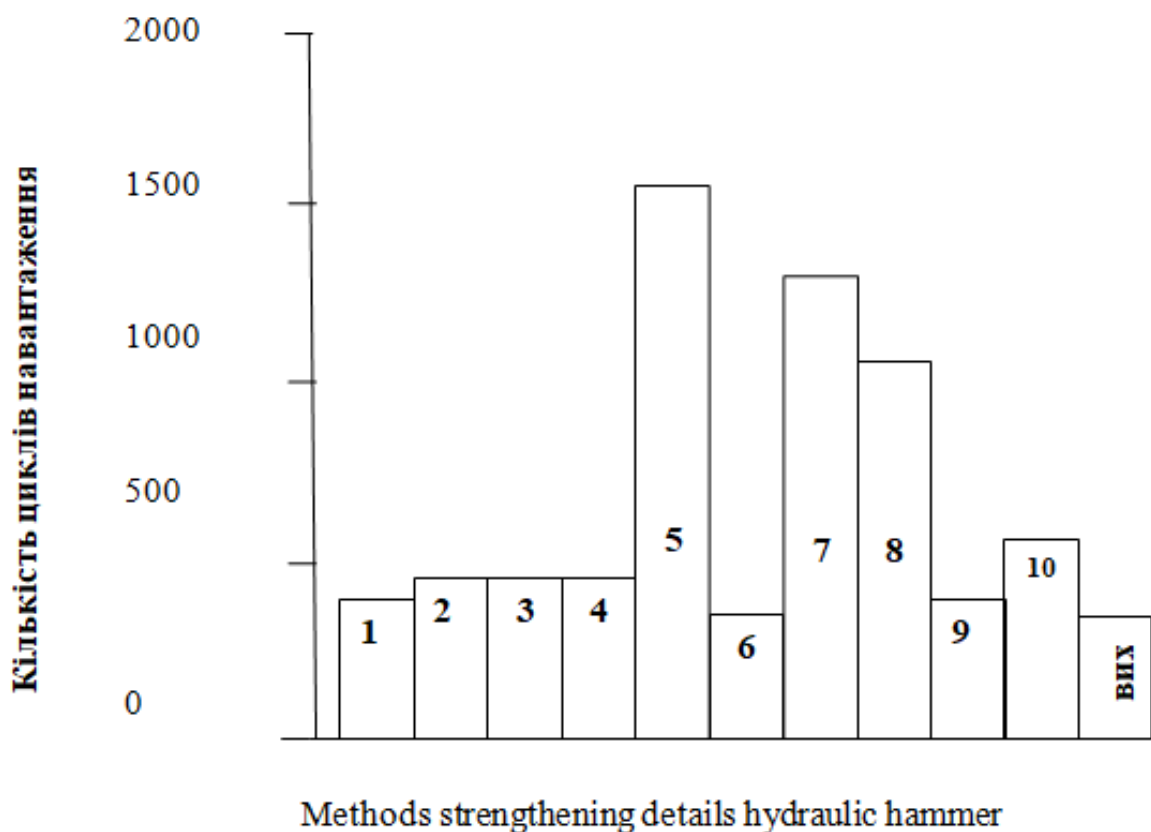
Figure 14.2. Diagram of wear resistance of hydraulic hammer parts depending on the type of hardening: original – without additional hardening, 1 – ion-plasma chromium plating; 2 – ion-plasma chromium plating using improved technology; 3 – laser heat treatment; 4 – carbonitride coating; 5 - surfacing alloy "Hastelloy"; 6 - electric spark alloying; 7 - detonation strengthening; 8 - chromium plating By sumsko-Swiss technologies; 9 - chromium plating decomposition of the compound "Barkhos"; 10 - galvanic chromium plating

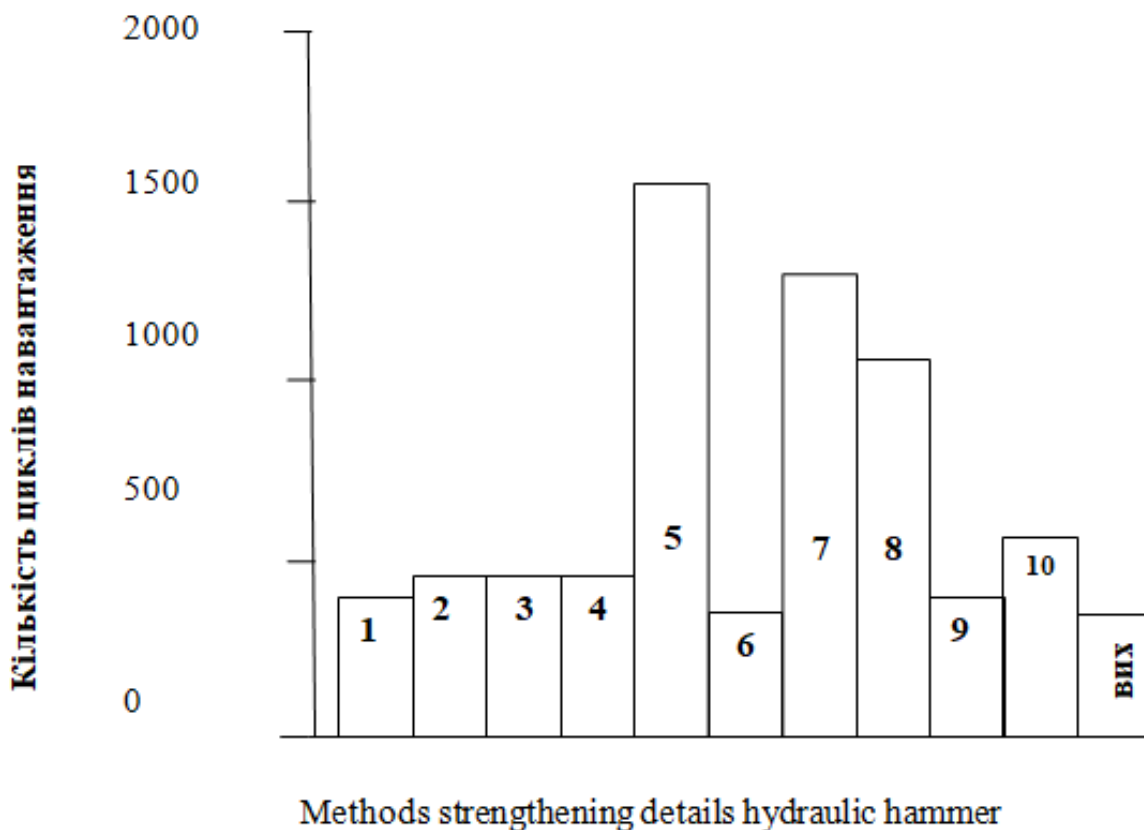
Figure 14.3. Quantity cracks V section striker (zone "M")

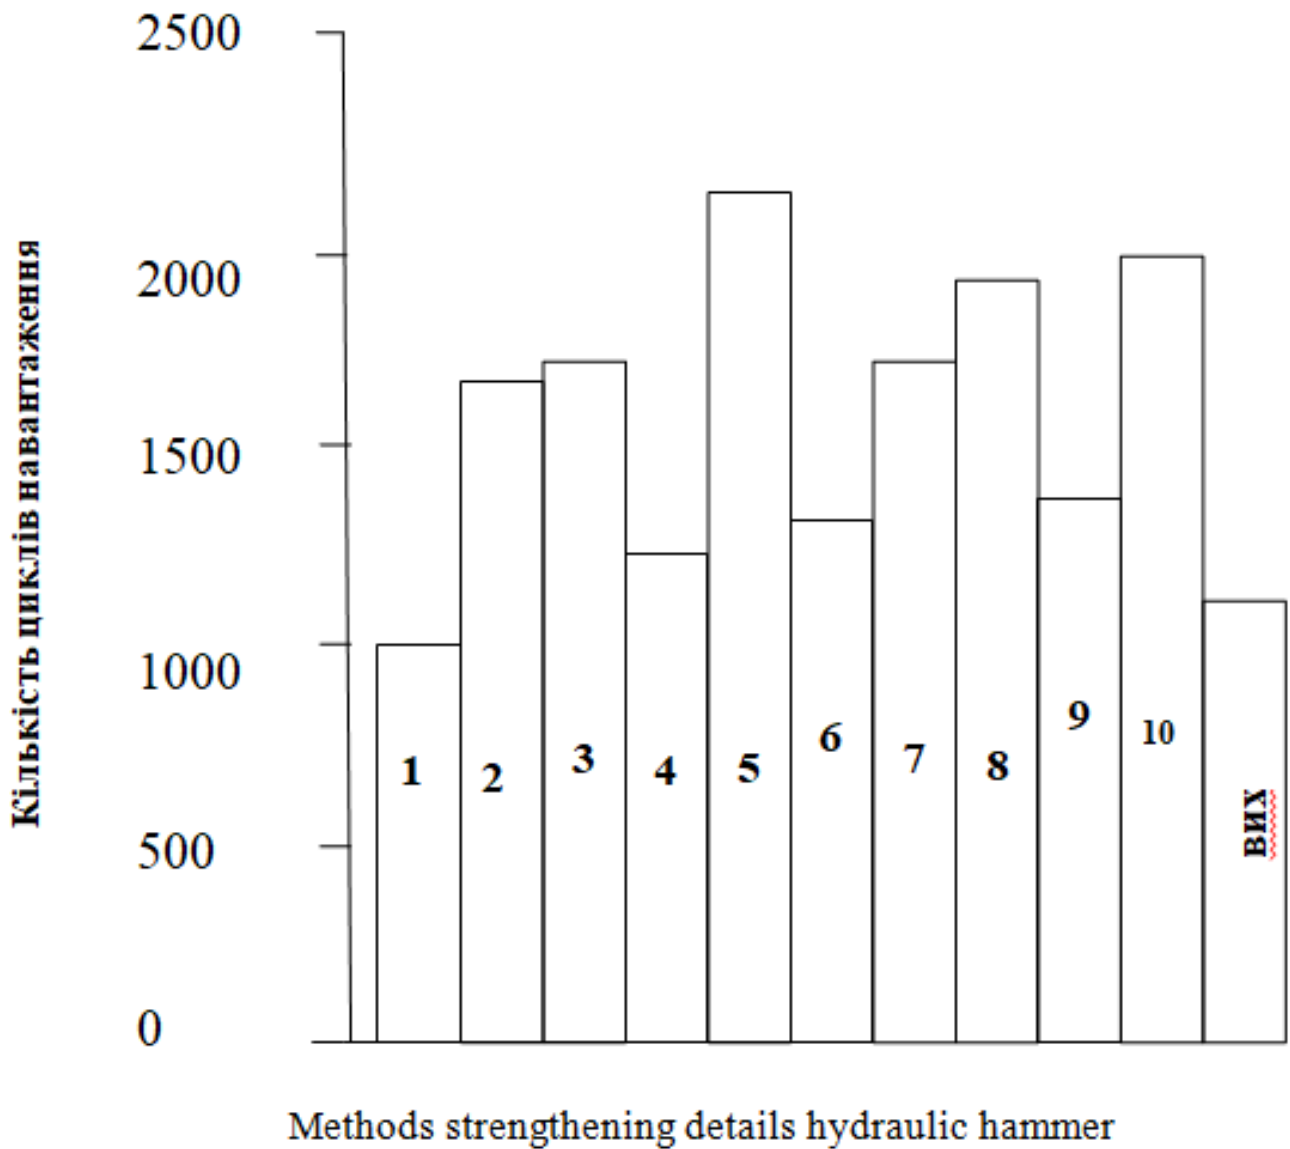
Figure 14.4. Quantity cracks V section channel corps (zone "WITH")
