PERSPECTIVE OF INTERNAL COMBUSTION ENGINE

THE METHOD OF EXPERT ASSESSMENT OF THE TECHNICAL CONDITION OF AN AUTOMOBILE ENGINE AFTER OVERHEATING

Khrulev A. E.[1], Saraiev O. V.[1]
[1]Kharkiv National Automobile and Highway University

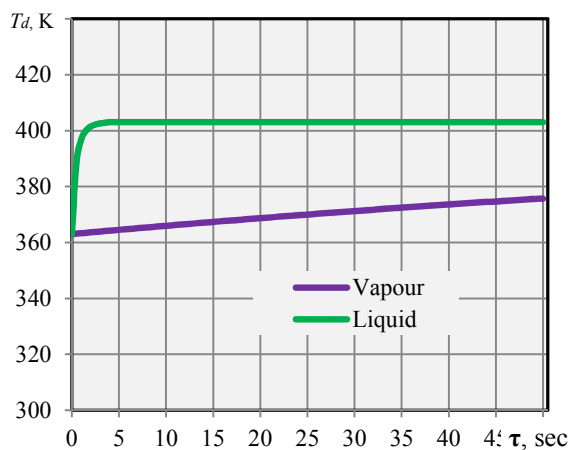
Let us now assume that the temperature of the working medium suddenly jumped up from 90 ^{0}C to 130 ^{0}C, i.e. by 40 ^{0}, which means that the engine has overheated. When all the values are substituted into equation (4), we shall get that the sensor, being in the coolant, will follow the coolant temperature with a delay of no more than 1–2 seconds (the temperature of the sensor in the liquid will increase by 40 ^{0}C per about 1 second). At the same time, the delay in the reaction of the temperature sensor for vapor will be extremely large, approximately 0.3 ^{0}C in 1 second or only 18 ^{0}C per minute (Fig. 6).

Fig. 6. The calculated nature of the temperature variation of the temperature sensor element from the point of the cooling failure with the sudden rise of the temperature from 90 ^{0}C to 130 ^{0}C (from 363 K to 403 K)

This result shows that with an abnormally rapid decrease in the coolant level in the cooling system or with its complete loss, the inertia of the temperature sensor increases by about 100 times. Under such a condition the sensor may be unable to track the temperature rise, while the entire time of the overheating process from loss of coolant to engine failure can be very small.

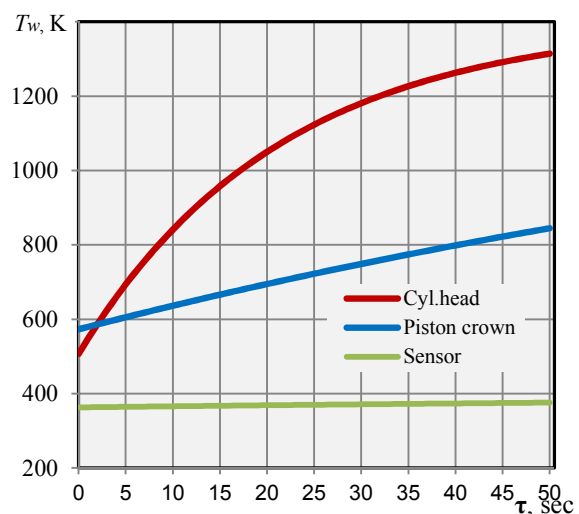
As follows from the calculation results (Fig. 7), in the event of a sudden and complete cooling failure, the combustion chamber wall can begin to melt already after about 10 seconds of engine operation in the nominal mode.

The piston crown heating in the event of a cylinder cooling failure occurs much more slowly than the heating at the cylinder head wall. That is why the appearance of scuffing on the piston top land should be expected in a period of time which is several times longer than the time of damage to the combustion chamber wall (Fig. 7).

For comparison, the diagram shows the temperature of the sensor element. The very small variation of this temperature during the accident up to engine failure allows us to conclude that the entire process of the engine damage before the melting of the parts (horizontal line corresponds to this temperature equal 850 K) can take place without informing the driver about the accident.

Fig. 7. The calculated nature of the temperature variation of the cylinder head, the piston crown and the temperature sensor over time from the moment of a cooling failure in the event of a sudden loss of coolant

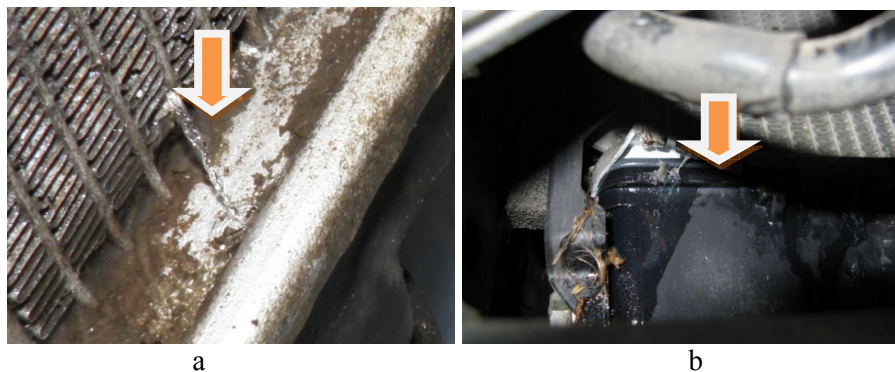
The main cause of this type of failure is the damage to the cooling system radiator from various foreign objects tossed up from the road by passing or oncoming vehicles (Fig. 8). But the failures with similar consequences that occur due to the aging of the rubber or hose defects, including hose rupture, the tearing off of the hose from the pipe due to the loosening of the clamp, etc. are also quite common.

Fig. 8. Typical radiator damage from foreign objects that causes rapid coolant loss: a – destruction of one of the radiator tubes; b – the edge of the lower radiator tank

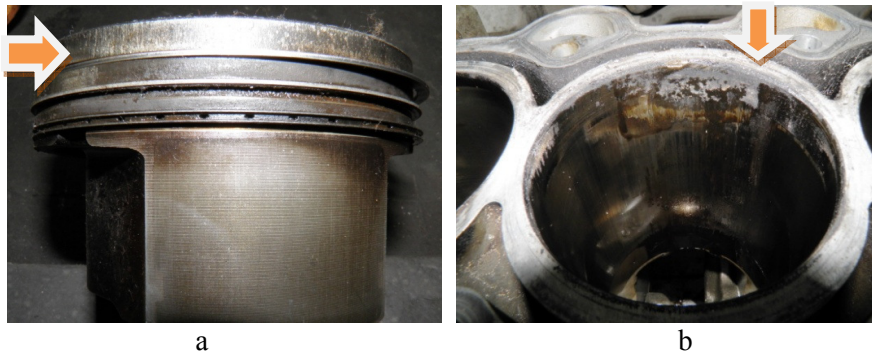
When the engine is working at low speeds and loads, the intensity of heating of the parts decreases and the process time increases. This causes the chamber wall temperature to balance, and instead of a local wall burnout between the seats, engine failure may occur due to the seats falling out from the cylinder head (Fig. 9). Typically, such failure occurs with an overall heating of the cylinder head above $200\,^0C$. What these two considered cases have in common is the minimal damage to the cylinders and pistons, dealt only in the upper part, where due to thermal expansion of the top land the piston can jam in the cylinder with characteristic traces of scuffing and seizure (Fig. 10).

Fig. 10. A gasoline engine operation at an emergency loss of coolant: a – scuffing and seizure on the top land of the piston; b – the cylinder

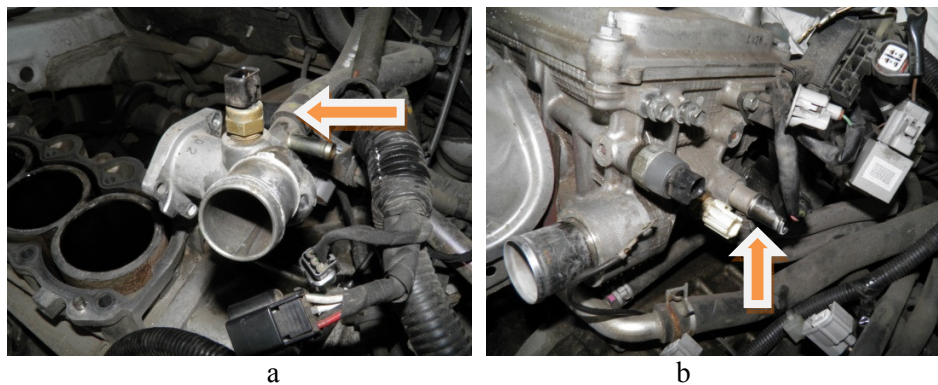
Common to the considered cases of failure is lack of the driver's reaction to overheating and the continuation of the trip until the engine stops due to failure . This indirectly indicates the inoperability of the temperature sensor if it is installed on the outlet pipe of the cylinder head (Fig. 11).

As follows from the data obtained above, in the event of a sudden rapid loss of coolant, the inertia of the temperature sensor becomes extremely large if the sensor is installed on the outlet pipe far from the cylinder head.

In such conditions, the temperature at the pointer can increase noticeably for the driver only as late as a minute after the cooling system has completely failed, while an engine failure due to thermal deformation of the cylinder head occurs before the driver has a chance to see that the temperature of the engine has increased.

Fig. 11. Features of the temperature sensor typical location on the outlet pipe of the cylinder head, made: a – as a separate part; b – as a structural part of the head
